BUILDING RECORDING IN 2015

SOMERSET VERNACULAR BUILDING RESEARCH GROUP

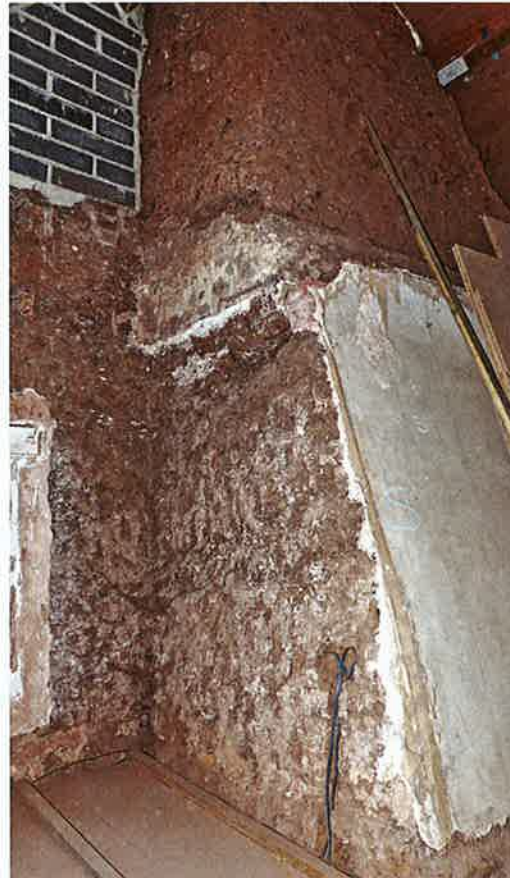
Fig. 1 Chilton Trinity, Braddocks Cottage. The enormous cob chimney as seen on the first floor

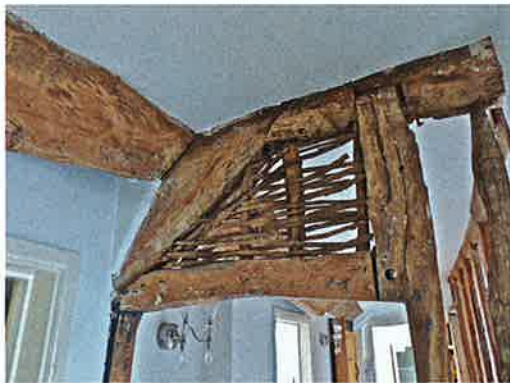
Fig. 2 Curry Rivel, Tudor Cottage:
remnant wattle panel

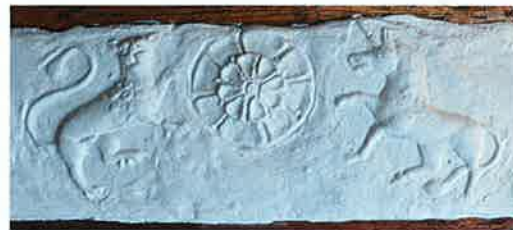
a 10cm chamfer. A plaster frieze above the lintel was decorated with several motifs including a lion and unicorn either side of a union rose. Above is a wooden cornice. Stairs, with a candle niche, were also inserted. The stone-mullioned window was built into the front wall of the inner room.

Fig. 3 Curry Rivel, Tudor Cottage:
Lion and Unicorn

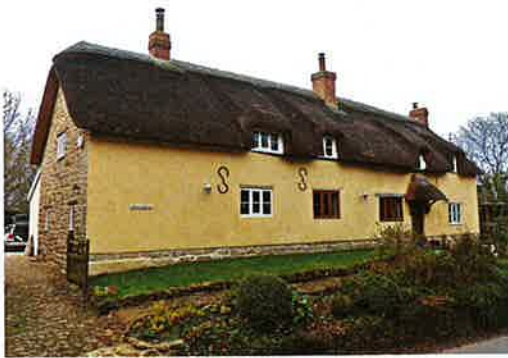
Shown on the 1885 Ordnance map as three dwellings the house has since been restored to a single dwelling. The main range is thatched one and a half storeys comprising five rooms and the remnant of a cross passage. The walls were originally cob and are now of variable thickness reflecting subsequent repairs and alterations. A single smoke-blackened truss with a vertical joint to the principals and clean on one face leads to the deduction it was built as a two-unit open hall house with an inner room and a solar above perhaps in the

Fig. 4 Dowlish Wake, Mount Cottage,
front elevation

late 15th century. What is thought to be the remnant of a wind eye remains at eaves level of the hall. The hall today has a good plank and post partition at the east end separating it from the inner room and at the west end a timber-framed smoke hood. Behind this fireplace is the cross passage marked by a head beam with mortices for a former partition. Two roof trusses with framing define the gables of the three-room and cross-passage house and in addition to the blackened truss there is another of jointed-cruck construction at the back of the smoke hood. Carpentry details suggest that the original hall house was enlarged in the late 16th century and

this is confirmed by the dendrochronology dates supplied by the owner showing various timbers with felling dates mainly in the period from 1580 to 1590. The floor of the solar was replaced in the 17th century, the new joists being supported on an axial beam with keel stops dating to 1676. In the 19th century a new brick-built inglenook fireplace, complete with an oven, was inserted in the inner room and the stack was built free-standing to the east of the original gable framing. The house was extended to encompass the stack. At the west end too the house was extended and small fireplaces incorporated in the gable wall.

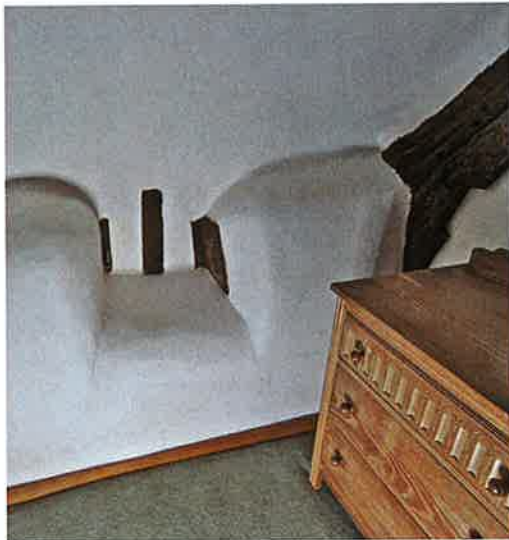
Fig. 5 Dowlish Wake, Mount Cottage:
supposed wind-eye

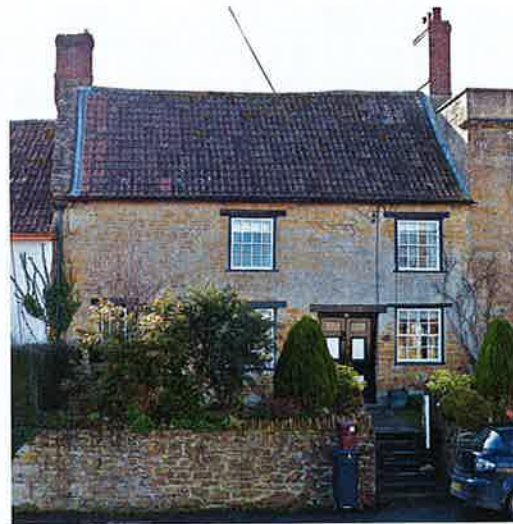
Fig. 6 Martock, 98 Bower Hinton, front elevation

This Listed property, a shop in the mid 19th century, is now part of a terrace of continuous houses but originated as a large element of a two-unit cross-passage dwelling. The front and rear ground floor walls are 80cm. thick; the front wall is based on good quality ashlar. The walls and former thatched roof have been raised. The two numbered (II and III) jointed crucks and surviving purlins, wind brace and lower rafters are all of elm and smoke-blackened.

The above details plus the internal span (6.3m) and the bay width (4m) suggest a late 14th/early 15th-century date of build when the property was an open hall house. During the 16th century a smoke bay may have been inserted, perhaps quickly

replaced by a smoke hood (remnants of this remain on the east gable) when the second floor, supported by a new beam, 12.5cm chamfer with cyma stops, was inserted.

Late in the 18th or early 19th century a stone partition split the house lengthways creating smaller rooms at the rear. In the late 19th or early 20th century sash windows were inserted and a barn built behind the house. An entrance to the barn is through a depressed four-centred doorframe with ogee moulding, the accompanying door, double planked with diagonal planking on the back, may have come from the rear of the cross-passage and would date from 1600.

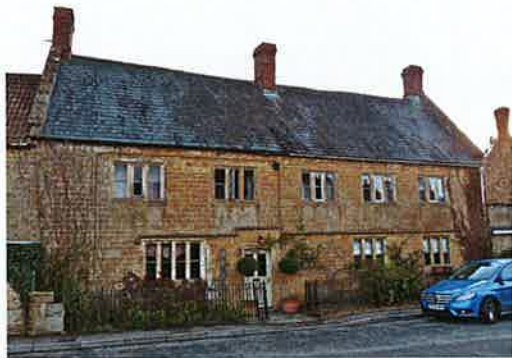
Fig. 7 Martock, front elevation of No 6, Hurst Lodge

The survey primarily covers Hurst Lodge and mentions the adjoining former barn (Osborne Cottage). The house is three rooms in-line with cross passage and two rear outshots/lean-tos.

The wall thicknesses (60cm), irregular wall corner angles and the small size of the parlour suggest that the present house stands on an earlier footprint, also that some of the extant features (the fine mouldings on the framed ceiling and the front entrance door) are reused from this property.

The first-floor symmetry of the present, two-storey building, the hollow chamfer mullioned windows, a continuous drip mould and a diagonally chamfered front wall plinth suggests construction *c.* 1700 using quality ashlar Hamstone. The formerly thatched roof is supported on three, unequally spaced, tie beam trusses and two rows of trenched purlins fixed with square pegs. F3 in the Service

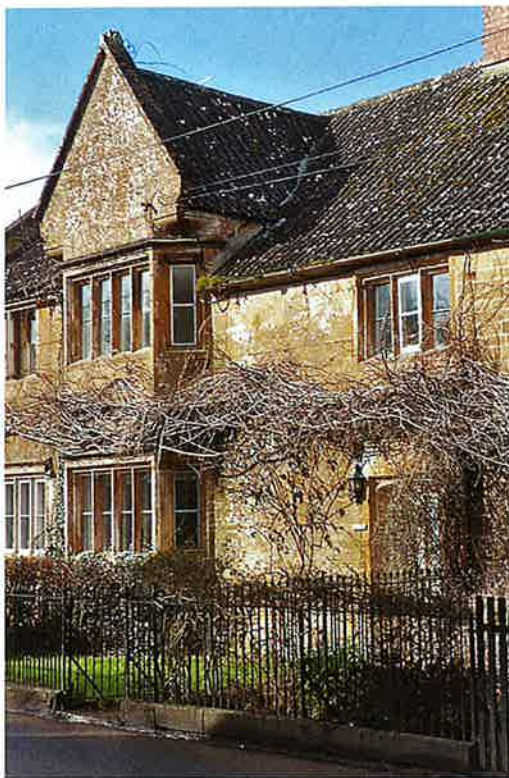
Fig. 8 Martock, 9 and 11 Hurst, the two-storey bay with corbelled gable

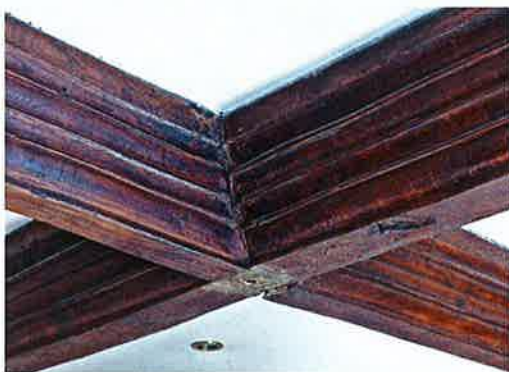
depressed four-centred arch heads, plain spandrels, hollow-step-ogee mouldings, and a double tier of bar stops on the jamb some 37cm. above floor level; door D3 and the 6 panelled, 12cm. deep, richly moulded framed ceiling.

Fig. 9 Martock, 9 and 11 Hurst, moulded beams in framed ceiling

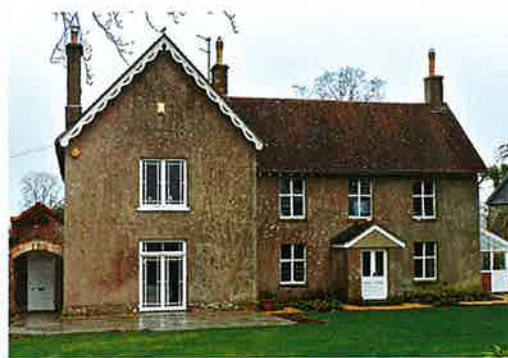
Fig. 10 Penselwood, The Old Rectory, front elevation

This Listed property is built of local Shaftesbury sandstone rubble, part rendered, under pitched roofs of plain or fish-scale clay tiles. Decorated bargeboards embellish the west and south gables. Surveyed were the two storied north and south ranges, the latter with attic, and an eastern single-storey range.

The VCH notes "a Parsonage house here in 1606. In 1815 it was described as unfit and small, in 1840 it was uninhabited but under repair". The south range contains remnants of a 17th-century, one and a half-storey building comprising two rooms with a central passage, wall thickness c. 60cm, an inglenook with large orthostatic jambs with a 10cm chamfer and 'ball' stop, and a summer oven at the rear. The adze-dressed oak lintel, mitred to the jambs, is slightly peaked with a 10cm chamfer. Taper burns and scratches on it may have been deliberately made as apotropaic marks.

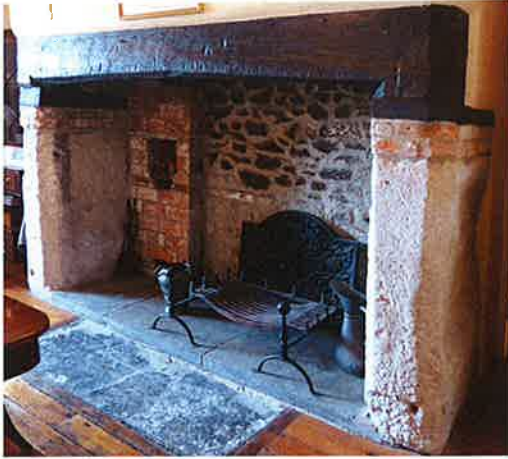
*Fig. 11 Penselwood, The Old Rectory,
main fireplace*

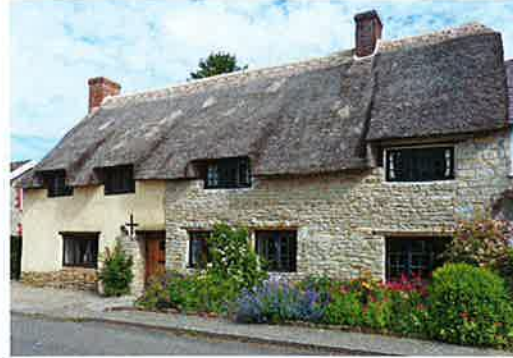
This Listed dwelling (previously The Nook) is three rooms in-line and cross passage rising to one-and-a-half storeys under a thatched roof. A single-storey lean-to is at the rear, north, of the property. The house is constructed of local lias stone with some cob, largely rendered and painted, with timber box-framing at first floor level. Wall thicknesses range from 60 to 81cm. Timber-framed windows sit under timber lintels. Lias flagstones are to be found throughout. The present roof over-sails the original which had a 51 degree pitch and was supported on four collar and tie beam trusses; that at T2 was formerly closed.

In the early 17th century this three-unit cross-passage yeoman's cottage was constructed from cob with timber framing above the wall plate.

Fig. 12 Rimpton, Brambly Cottage

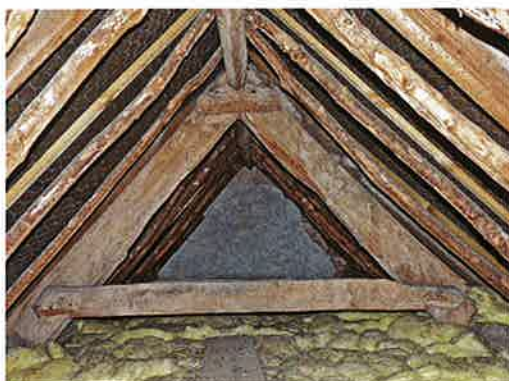
A two-room, central-entry, one and a half-storey main range with a rear wing and a west gable single-storey extension. All built of local random rubble stone, 50cm thick, with a painted finish. The core was built around 1800 and the original, elm roof is over-sailed by the present one. The former was supported on two collar trusses with the collar half-dovetailed into the principals. The common rafters are all of coppiced poles, perhaps of ash.

Fig. 13 Rodney Stoke, Holly Farm. Pole rafters of un-squared timber

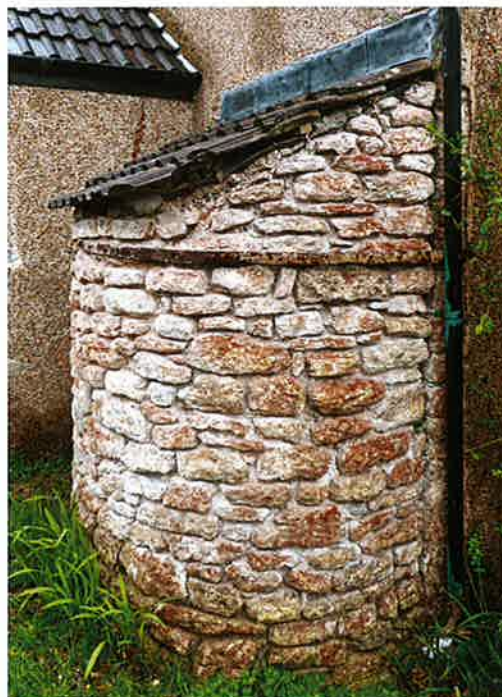
Fig. 14 Rodney Stoke, Hollybrook Farmhouse, housing for an added oven

to serve as a kitchen, walls 51cm thick. A baking oven in the inglenook is housed in a purpose-built projection. To simplify access to the upper floor the stair was turned. In the attic the roof slope was plastered onto the thatch and a ceiling inserted, requiring the cranked collars to be raised.

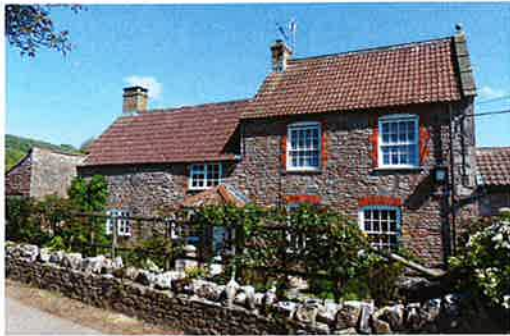
The house comprises a two-room, one and a half-storey range to the north of a two-storey single unit; behind this latter is a one and a half-storey unit, under a cat-slide roof, and a single-storey room. All are built of local random rubble stone with segmental window heads in brick and additional facings on the two storey section.

Originally non-domestic, this 18th-century building, possibly a barn or cart shed, was repaired

Fig. 15 Rodney Stoke, Myrtle Cottage, front elevation

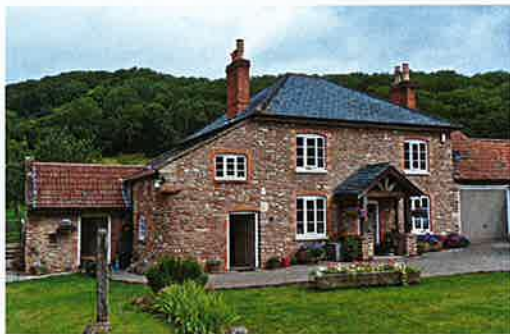
Fig. 16 Rodney Stoke, Scadden's Lane, Scadden's Farm, front elevation

A rectangular, two-room building of local random rubble stone, 52cm thick, was erected in the early 19th century utilizing the 62cm thick wall of a former building. A full width rear lean-to of one and a half storeys was added shortly afterwards for service or farming activities. The house was enlarged and up-graded at the end of the 19th century with the lean-to becoming two-storey and the property re-roofed; a single hipped slate roof was erected over the whole building. An additional lean-to at the west gable was probably added at this time and is now incorporated in to the living area.

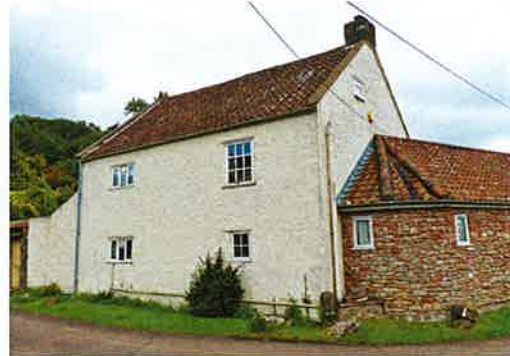
Fig. 17 Rodney Stoke, Scadden's Lane, Scadden's House, rear elevation

Documentary evidence implies an earlier building on site replaced by this late 18th century main unit. Upgrading and the addition of the lean-to was mid 19th century. The western extension dates from the late 20th century.

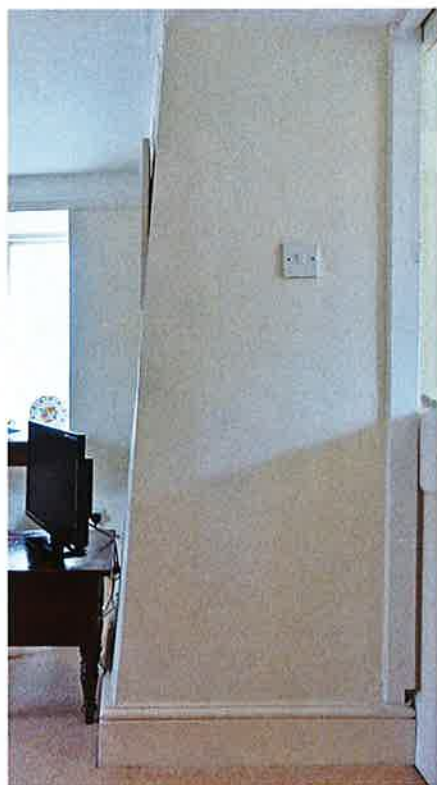
Two rooms of the front-range were probably built about 1700 for non-domestic use perhaps in conjunction with an adjacent mill. The walls have a significant batter being 63cm increasing to 70cm nearer the floor suggesting load bearing and industrial use. Steam power improved the fortunes of the mill in 1781. In the late 18th century, perhaps when it all came into domestic use, the front range was completed with another room, wall thickness 54cm, containing a modest inglenook

Fig. 18 Rodney Stoke, Stoke St, The Anchorage, wall batter

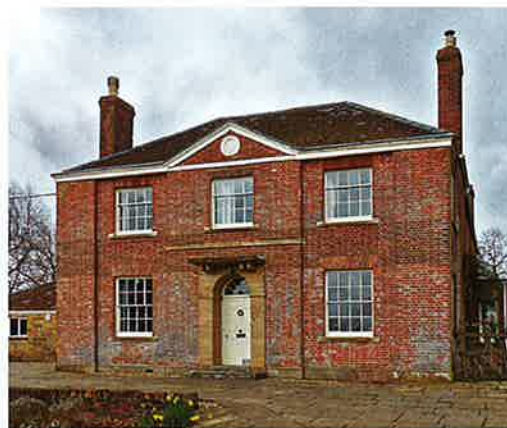
The plan is a two-storey front range of two rooms and hallway with two additional two-storey ranges behind enlarged by single storey projections and a canopied way. Each range has hipped roofs

The early 19th-century construction in brick (walls 40cm thick) denotes 'status' (Brick Tax, 1784–1850) in a town of Hamstone buildings. The initial Georgian front range comprised dining room, parlour, hallway, study and stairs plus an underground cellar. A suitably-sized kitchen must

Fig. 19 South Petherton, Coles Farm, front elevation

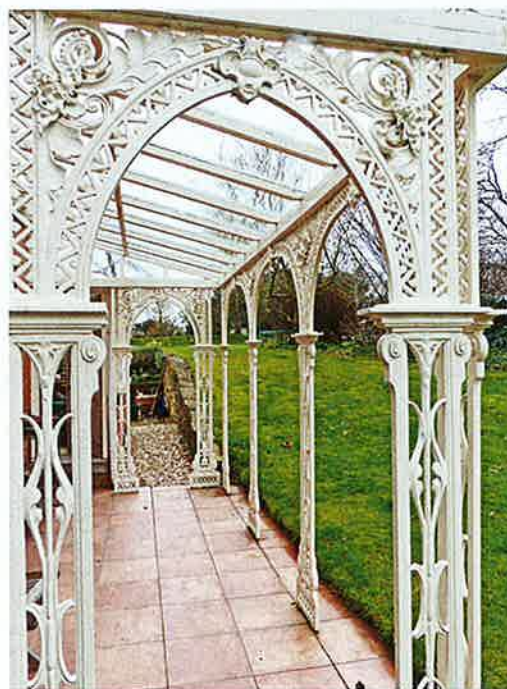
Fig. 20 South Petherton, Coles Lane, 1877 Coalbrookdale iron verandah

A second two-storey range was added in 1829 (chalked date) perhaps creating a permanent link to the outbuilding. Upgrading occurred in the late 19th century: cast-iron verandah, sash windows with reinforced frames, alcoves with three-centred heads around a repositioned fireplace, stables and other outbuildings again with three-centred heads to doorways. In the early 20th century a second floor was added to the postulated detached kitchen; the doorframes and architraves are wider than elsewhere and the four panel doors have lower lock rails.

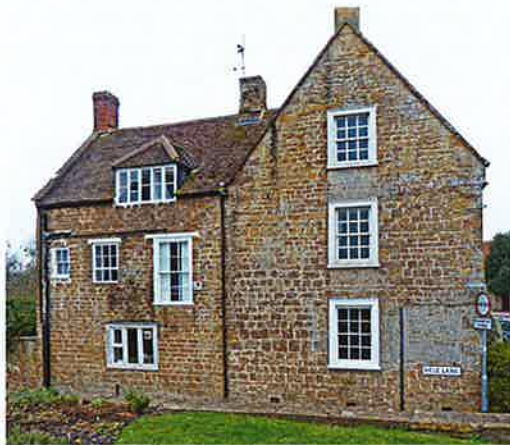
Fig. 21 South Petherton, 1 West St, east gable with false chimney

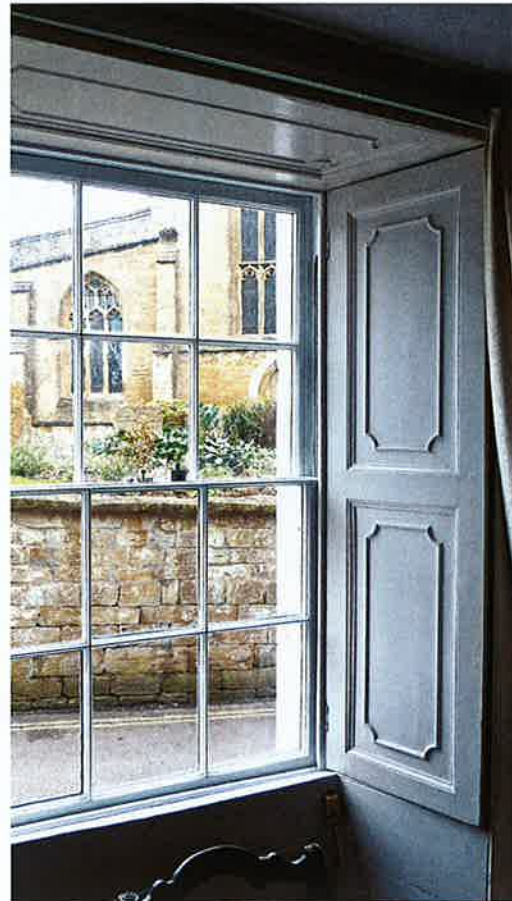
Fig. 22 South Petherton, 1 West St, shutters with applied beading

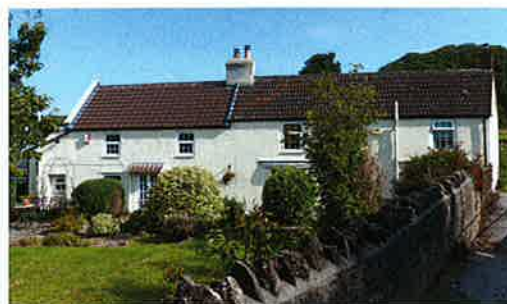
Built as two cottages it is now a single, two-storey dwelling with an extension at each end. Each unit has a separate roof with different eaves levels; the roof to the west has a raised and coped gable. External walls, some 50cm thick, are rendered and painted.

Early in the 19th century a modest cottage (kitchen/living room and service room) was constructed. Around 1850 a similar cottage was built against the east gable of the original. An auction poster from 1873 refers to the house as "The

Fig. 23 Winscombe, Grove Farm, front elevation

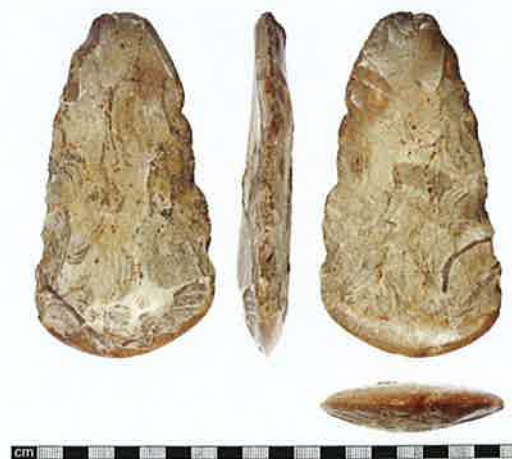
A Neolithic flint polished axehead (Fig. 1) dating to the period c. 2750–2350 BC. The axehead is sub-ovate in shape with a thin butt and is lenticular in cross-section. It has been bi-facially worked, with flaking scars covering both faces. The cutting edge has been ground and polished to remove

The axehead measures 132.13mm in length, 68.38mm maximum width, 22.71mm minimum width, 18.57mm maximum thickness, 2.14mm minimum thickness and weighs 203g.

Fig. 1 Axehead from Exford
