BUILDING RECORDING IN 2013

SOMERSET VERNACULAR BUILDING RESEARCH GROUP

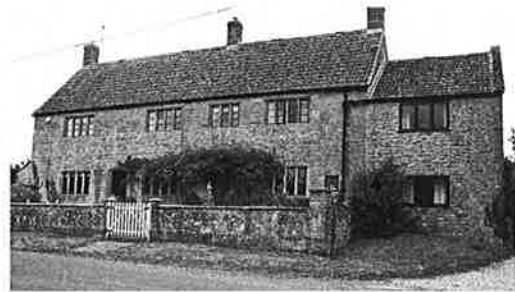
Fig. 1 Ash, Milton, Black Hall (photo F. D.)

The plan is 2 storey three rooms in-line with cross passage. The construction is of cut and squared Ham-stone under a double-Roman clay tile roof with the highest quality stonework on the façade. An attached south gable outhouse/barn, possibly late 19th-century and formerly with double wagon

A major fire in 1852 has rendered precise interpretation difficult. However a 16th or early 17th century date of build is indicated by stone-mullioned windows facing the road and the forecourt wall both stylistically belonging to this period. The service/kitchen had a large gable fireplace which now has a 33cm square timber lintel with a small chamfer. The original 6-panel elm framed ceiling in the hall with 16cm chamfers has largely survived but the site of the original inglenook fireplace in this room is now occupied by an inserted stair in a remodelled cross passage. Rear extensions depicted on the 1775 Duchy estate map may be those that still survive.

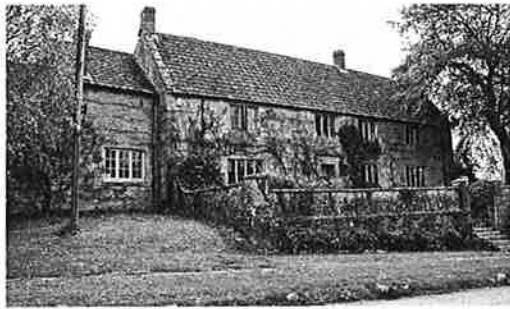
Fig. 2 Ash, Milton, Falconers Farm (photo F. D.)

The plan is traditional, three rooms in-line with a former cross-passage. Once thatched the roof is now clad in single Roman clay tiles. Three sides of the main house and the forecourt wall are in high

quality, large Hamstone ashlar in part sitting on a hollow chamfered moulded plinth. Early half-round stairs are presumed to have risen through two floors to the attic at the parlour gable; more modern stairs of the mid 19th century rise in a straight flight from the former cross-passage. The parlour fireplace is low in height, for heating only; it has ogee-step-hollow mouldings and a depressed 4-centred lintel with plain incised spandrels. The walls, the ceiling height, window style (mullioned with ovolo mouldings) and size, and front door surround (incision-deep ogee-step-wide flat-step-wide flat-incision) all indicate a prosperous house of the early 18th century and builders with conservative/traditional ideas.

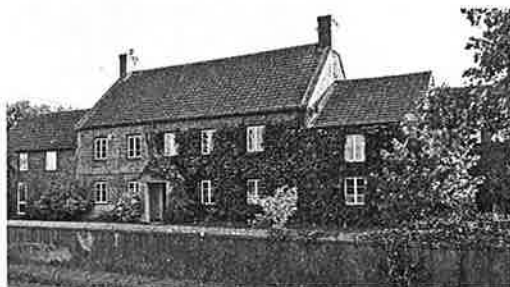
Fig. 3 Brent Knoll, West Croft Farm (photo John Rickard)

The plan of the double-pile main house is of two principal rooms, an elaborately panelled parlour

and a kitchen separated by a passage leading to service rooms at the rear. Two-storey, built in the early 18th century of local brick on a plinth of local lias stone, which on the front elevation rises to ground floor window sill level. The windows and door to the front elevation are symmetrically arranged; the openings all have segmental heads. A string course of three bricks above the ground floor windows extends almost the length of the west face. The coped gables are raised and each supports a chimney stack and attic windows. The replaced roof is clad with clay tiles.

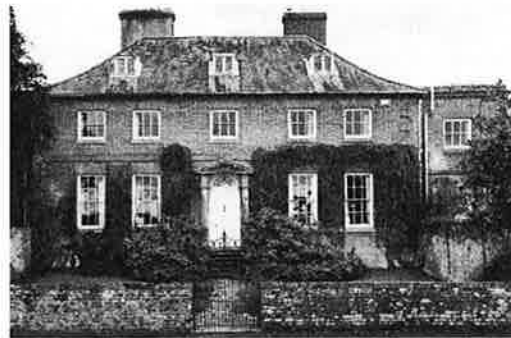
Fig. 4 Chetnole, Dorset, The Court (photo Knight Frank LLP)

This gentry property was built of brick c.1760. The core plan is 2 storeys with attic and basement around a central stairs passage, early 19th-century extensions flank the building. At this time the present low-pitched hipped slate roof with dentil cornice was erected. The front elevation features: a flight of moulded Ham-stone steps; an entrance door with a semi-circular ornamental cast-iron glazed fanlight, a classical surround with Tuscan columns, supporting triglyphs, an open pediment and modillion blocks; a moulded string course; gauged brick arches over ground and first floor windows; raised brick quoins; a stone band course at ground level; a raised band course under the ground floor windows complete the picture.

Windows: the basement has stone hollow-

chamfered Ham stone mullions, the ground floor has 4 sashes with glazing bars, shorter versions are to be found on the first floor, the attic has flat-roof dormers with casements and leaded lights.

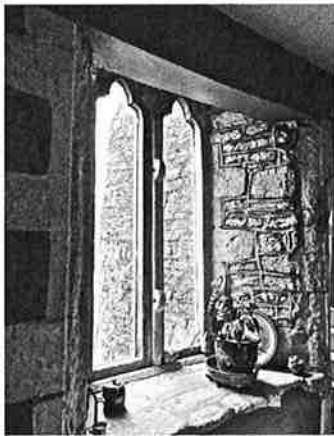
Fig. 5 14th-century window: Emborough, Manor Farm (photo John Rickard)

The late 14th-century cross wing (wall thickness 90cm) was built as a complete building, either an open-hall or of one-and-a-half storeys. A Douling stone plate tracery window of two-lights each with twin cusped heads, now re-sited, is believed to have lit this dwelling.

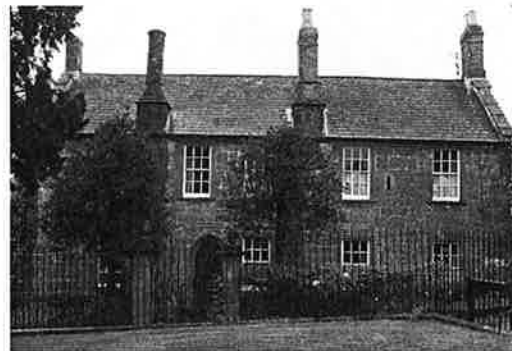
Fig. 6 Ilminster, The Chantry (photo Mike Hargreaves)

This is one of several chantry priests' dwellings built around the Churchyard of St. Mary's Church during the mid 15th century. Constructed of large blocks of coursed, roughly squared Moolham stone (a local Marlstone) with wide joints, Ham stone dressings, a slate roof with stepped stone copings, brick stacks to the gable ends and lateral stacks flanking the door.

Early 18th-century upgrading included re-fenestration of the front elevation, 6 over 6 pane sashes with horns in smooth ashlar bead moulded surrounds.

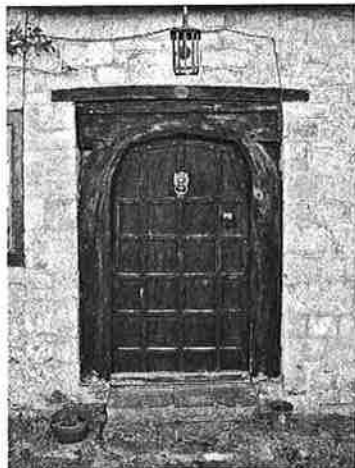
*Fig. 7
Ilminster,
Ilford, The
Old Cider
House
(photo Mike
Hargreaves)*

L-shaped plan, single storey with attics. Constructed of local Moolham and lias stone under a thatched roof with half-hips. The roof is supported by 5 trusses linked by three trenched purlins each side and a ridge piece. Two trusses are of post-and-panel (wattle and daub in the panels) construction, two comprise side pegged long-tenon jointed crucks with cambered collars.

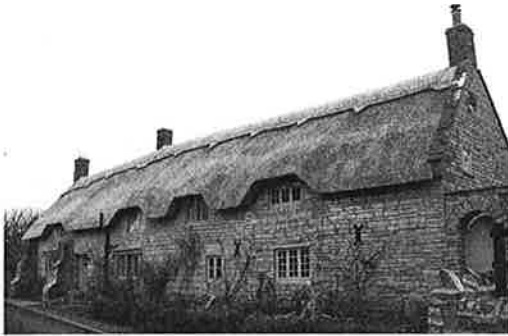
*Fig. 8 Long Sutton, West Knole House
(photo Mike Hargreaves)*

Formerly three rooms in-line with an axial addition, cross passage, turret-staircase and more recent lean-to additions. Built of cut and squared local lias stone with Ham stone dressings under a thatched roof set between stepped, coped gables all

supported on three cambered collar trusses linked by two tiers of trenched purlins, scarf-jointed at the principals with a ridge-piece notched into the apex.

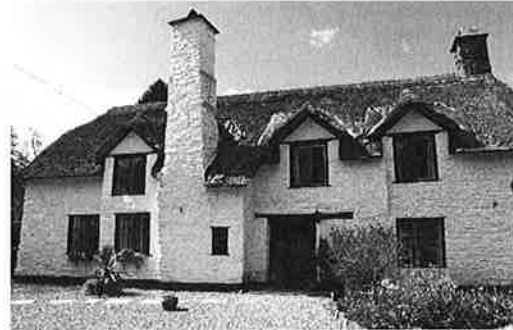
*Fig. 9 Monksilver, Woodford, Court Cottage
(photo Ann Heeley)*

The plan is 3 rooms and cross passage in-line rising to one-and-a-half storeys. The early 17th-century building with wall thicknesses of 65cm, segmental and depressed four centred head doorway details, a post and panel partition, turret stairs, closed jointed-cruck trusses and 'nick' stops on the jambs of the fireplace, was constructed from painted random rubble. The half hipped thatched roof is supported on jointed cruck trusses with a gable and a lateral stack. The first floor, accessed by the turret stairs then extended the length of the house.

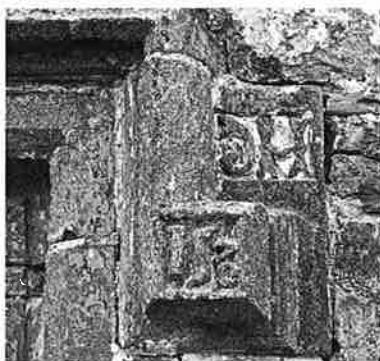
Fig. 10
Datestone:
North
Curry,
Manor
Farmhouse
(photo Ann
Heeley)

The relatively sophisticated and generous two storey plan, comprising four rooms and cross-passage in-line and 4/5 hearths, suggests an occupier of yeoman or gentleman status and a date of *c.*1570. The walls are formed from a variety of local stone with Ham-stone dressings to doorways, window mullions, surrounds and hood mouldings. Some first floor walls contain cob, the remnants of the original build.

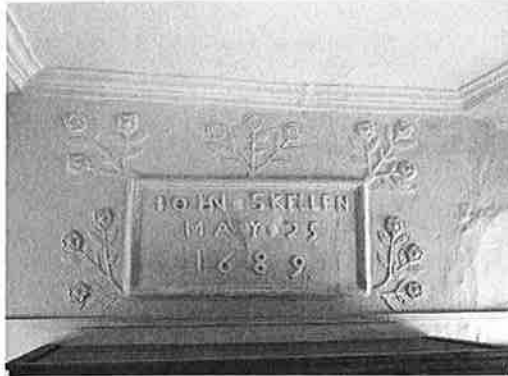
Fig. 11 Plaster plaque: Seavington St Michael, Orchard Cottage (photo John Rickard)

The present plan is three rooms in-line. It was built in the mid 16th century possibly of cob, now replaced with local stone, under a thatched roof supported by 4 trusses and a diagonally set ridge piece. 3 of the trusses are of face-pegged jointed cruck

construction with two tiers of trenched purlins. The collar is tenoned to the principals. The feet of the trusses appear to have been vertically trimmed and rest on timber pads just below the eaves, all indicating a rare South Somerset roof form. One end truss was closed with wattle and daub, plastered and whitewashed on one side only. Horizontal slots in the upper purlin above the hall may have been associated with a smoke hood. Beam chamfers are generally 17cm and have rounded step-and-run-out stops. Plaster work exists in the principal first floor chamber, both on the raised ceiling and in a plaque on the wall, bearing a date of 1689, a time when the dwelling was occupied by the largest ratepayer in the parish.

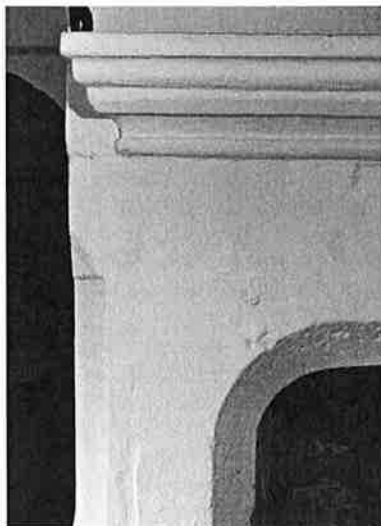
Fig. 12 Fireplace mouldings: Shepton Mallet, Charlton, Woodlands Farmhouse (photo John Rickard)

The original house, probably built in the early 16th century with walls 70-65 thick, comprised two rooms with a gable entry (a full 4-centred arch in Douling stone with a 13cm plain chamfer and diagonal stops) into the hall. This was heated by a fireplace with a plain chamfered (10cm) square head, a jamb has step-and-run-out stops both top and bottom. The stone lintel incorporates a stone mantel shelf. An upper floor was accessed by stairs alongside this entrance. The inner room, with lateral beam and shoulder stops, was heated by a lateral fireplace with a depressed 4-centred head and plain 10cm chamfers; beside it is an oven structure.

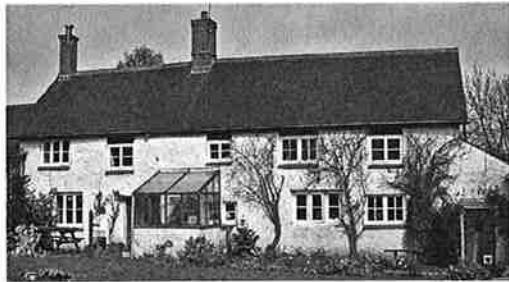
Fig. 13 Tracebridge, Whipples Farm
(photo Mike Hargreaves)

Plan: two-storey, three rooms-in-line, cross passage and newel stair turret with lean-to addition. Constructed from plastered stone rubble with some cob, under a slate, gable ended roof, formerly thatched and hipped at both ends.

The late 15th-century, 2-unit core of the property is smoke blackened throughout the jointed cruck roof. Both crucks have exceptionally long tenons, a slightly cambered collar and are linked by a pair of trenched purlins. The gable entry doorway into the hall has a semi-circular head and jambs with flat chamfers held to the head with wood-pegged mortice and tenon joints. The inner room was unheated. A fireplace was inserted in the mid 16th century on the hall gable (local slate jambs and a

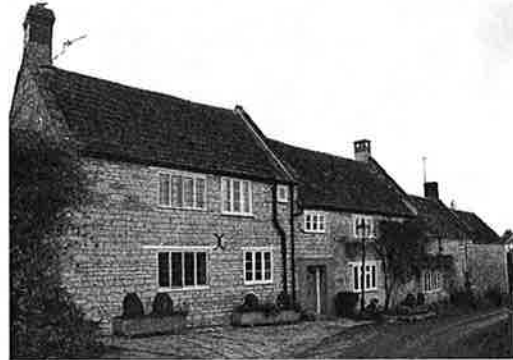
Fig. 14 Trent, Adber House and Cottage
(photo Mike Hargreaves)

Constructed of a mixture of local stone in the 18th century. Straight joints on the elevations and variations in roof-line indicate that the living-room and service room of the cottage, together with the first floor, were built as an addition to Adber House, but with no internal communication with it.

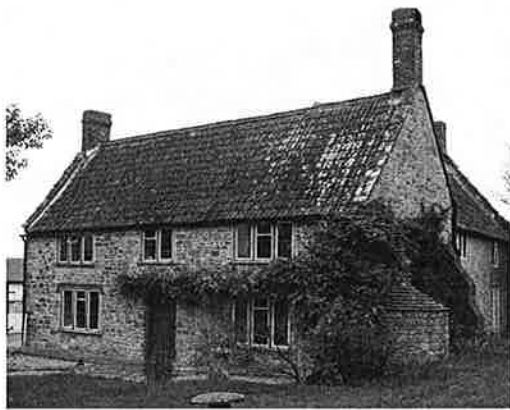
Fig. 15 Trent Adber, Lower Farm
(photo Susan Shaw)

trusses (3 open trusses with a pair of purlins each side butt jointed to the principals, a diagonally set threaded ridge-piece nailed-on, collar joined to the principals with half-lapped dovetails). It then was then one-and-a-half storey and comprised a parlour, kitchen with through passage and winding stairs (traditionally placed against the gable fireplace) under a thatched roof. In the late 17th century the north wing was added as a heated service room, probably a dairy/cheese room with some accommodation. Beams have shallow chamfers and run-out stops.

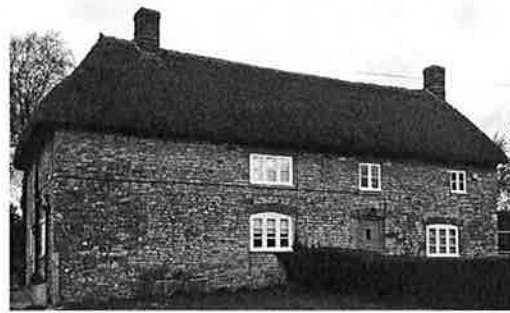
Fig. 16 Trent, 33-4 Malthouse Lane
(photo Mike Hargreaves)

Plan: two semi-detached, one-and-a-half storey cottages with random rubble walls except for some cob (85-90 cm thick) on the north elevation and a recently replaced thatched roof.

An early 17th-century build is suggested by a 4-panel framed ceiling, beam stops (12cm chamfers and step-and-run-out stops), wall thicknesses, remains of post and panel partitions and the fireplaces. The two properties were originally one cob construction; a traditional 3-rooms-in-line build comprising kitchen with curing chamber, parlour and a cellar/buttery. Entry was probably directly into the kitchen and access to the upper floor via a newel staircase in the parlour.

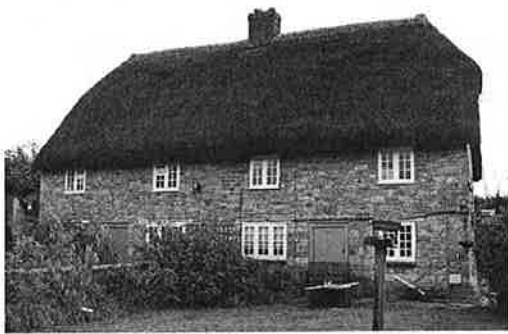
*Fig. 17 Trent, 35-6 Malthouse Lane
(photo Mike Hargreaves)*

The roof was raised in the late 18th century and the cob walling largely replaced. The curing chamber became a bread oven and it is likely that the house became two properties.

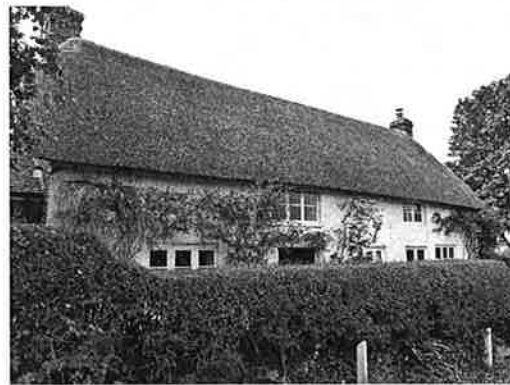
*Fig. 18 Trent, Mount Hunger
(photo Ann Heeley)*

The plan is 3 rooms in line and a rear single storey extension. The walls (50-55cm thick) are of random rubble-stone, part rendered and the roof is thatched. The core is probably a single room dwelling built in the early 18th century flanked by agricultural buildings. In the mid 19th century the rear lean-to was added and the building converted to two dwellings, a single room cottage (kitchen/parlour with chamber over), and a two roomed cottage (kitchen/parlour and service room with chambers over). All recently converted to one dwelling.

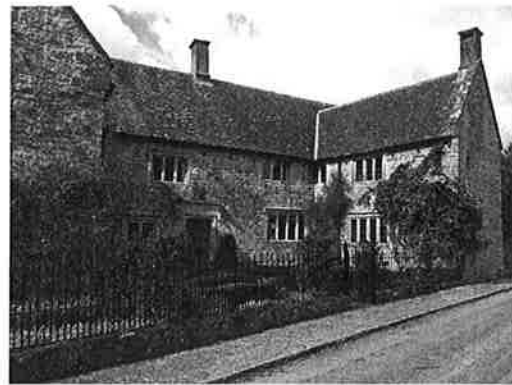
Fig. 20 Trent, Flambards (photo Mike Hargreaves)

The gable end of the north east wing is believed to be the remnant of a larger late 15th-century building lying parallel with the road. Exceptionally, the first floor windows do not have drip moulds. In the mid 16th century the northern section of the present main range, a two-storey, two room addition, was erected to abut the wing; it includes parts of the original 15th-century build. The present drawing room has a six-panel decorative plaster ceiling. The former service room doorway has a Ham stone moulded surround with an ogee-step-ovolo-step-ogee stop at the base.

Early in the 17th century the main range was extended southwards to incorporate a dining room and entrance doorway (Ham stone surround with ovolo moulded jambs and vase stops at the base). The head is 4-centred with sunken spandrels, the moulded label has deep step and return ends. In the mid 17th century (date stone 1658) a kitchen extension formed a second, south-eastern wing comprising two floors and an attic.

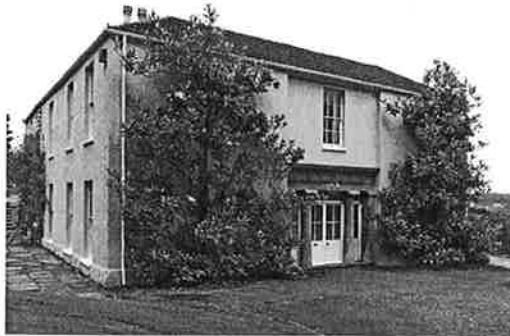
Fig. 23 Winscombe, The Old Vicarage
(photo John Rickard)

Numerous blocked doors and windows in the property are a reflection of the way the house has been adapted to the needs of the farm and its occupants.

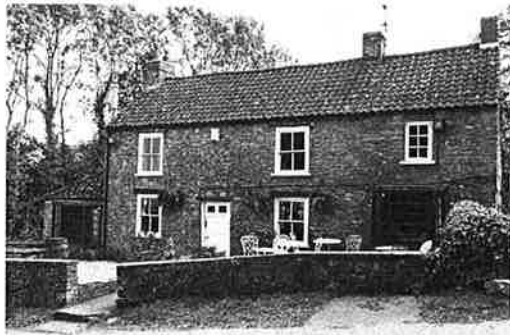
*Fig. 24 Winscombe, Crown Inn
(photo John Rickard)*

The Inn comprises a two-storey main range with a one-and-a-half storey catslide on the east side and an irregular northern single storey extension under a hipped roof. Constructed of local stone under a repaired clay tile roof but built *c.*1820, the original two rooms each had a gable fireplace and were partitioned by reed backed plaster. Further extensions were added to this *c.* 1880.

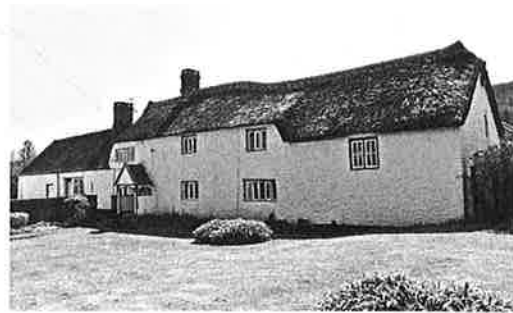
*Fig. 25 Winscombe, Pool Farm
(photo John Rickard)*

The plan is of one-and-a-half storey, comprising a main range and rear south wing. It is of a painted random rubble construction under a thatched roof which over-sails the original collar truss construction.

The core of the dwelling was probably built in the early 17th century as a two-unit house with a crossway (wall thicknesses, shouldered/geometric beam stops, size of roof timbers). A west gable extension of the late 17th century added a further room necessitating the insertion of a newel stair turret. Further improvements occurred in the first half of the 18th century: a south kitchen wing with cooking hearth and two baking ovens was built and the former kitchen upgraded to a parlour, introducing panelling, a genteel fireplace (smaller with a curved back) within in the former inglenook and a partition to create a cross passage.
