SOMERSET VERNACULAR BUILDING RESEARCH GROUP

Survey summary for 2006

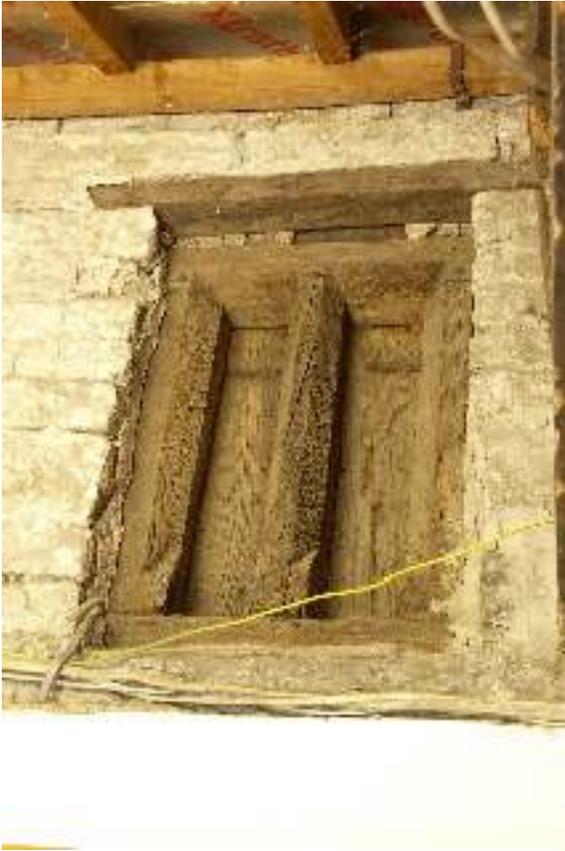
This is a two-unit central-entry house of one-and-a-half storey with additions on three sides. Originally it was single storey with the rooms open from the ground to the roof of four bays – the southern half being the hall and the northern half the ‘low-end’ service room. On the evidence of the arch-braced jointed-cruck trusses, a date in the 15th century is indicated (based on similar tree-ring-dated structures elsewhere in Somerset). The smoke-blackened roof extends over the northern (service) end and a fascinating detail is

the survival of wind-eyes, which helped to disperse the smoke (Fig. 1).

SVBRG has not previously recorded examples of these in Somerset and three survive here, two having their shutters still on the original pintles. However, the hall roof is not blackened, which indicates that either it was unheated or, more likely, that there had been a fireplace with a stack on the original south gable (since rebuilt). In *circa* 1600 the house was upgraded by the installation of a fireplace and stack in the kitchen, the framed ceiling over the hall, a staircase and first floors. At a later date, perhaps in the 17th century, the east front wall was rebuilt and the ‘workshop’ building added at the south end. Also the

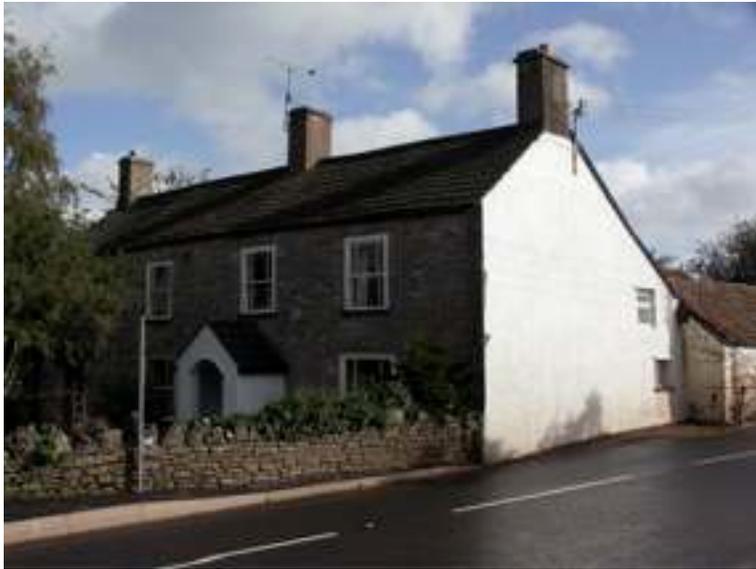
The house is comprised of a two-storey main part with two one-and-a-half storey lean-to additions on the east and a single storey on the north gable (Fig. 2).

Originally, the house was a two-unit gable entry plan, one room being an unheated service room, dating from the 16th century. The house had an upper floor from the outset and would then have been one-and-a-half storey. In the early/ mid-17th century the

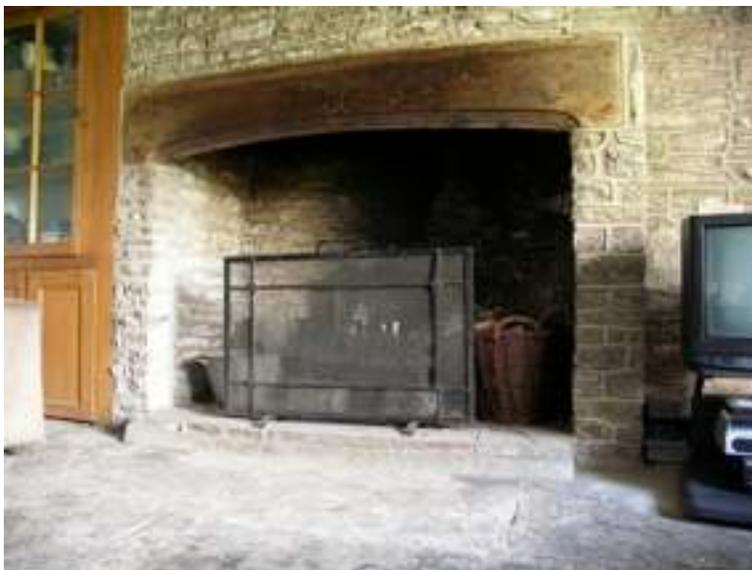
house was upgraded with a room, with an elaborate ceiling and a fireplace with a moulded bressumer (Fig. 3), added at the south end.

However, for reasons that are unclear, the west wall is misaligned with the existing building. The whole house was upgraded in the 18th century. Stairs were inserted and the upper floor was rearranged and the eaves and roof raised. The service rooms on the east side were probably added at this time as a kitchen, perhaps a bakery, and separate access to the servant quarters. (This house was also surveyed by E. H. D. Williams in 1982, who came to slightly different conclusions, but at that time did not have access to the roof.)

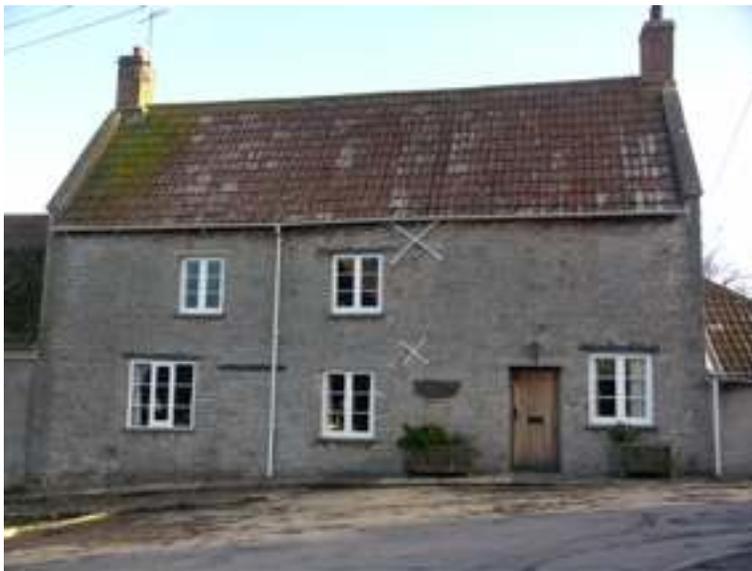
The house is two storeys, four units with additions (Fig. 4).

It was originally based on a two-unit plan with entry directly into the living room, and two unusually large service rooms. The stair is of solid baulk construction and its position

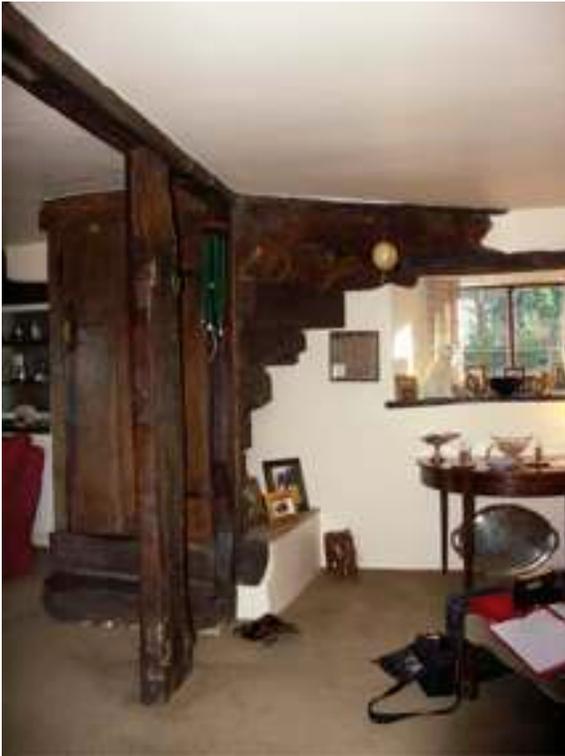
is uncommon, but known from a few other examples in Somerset (Fig. 5).

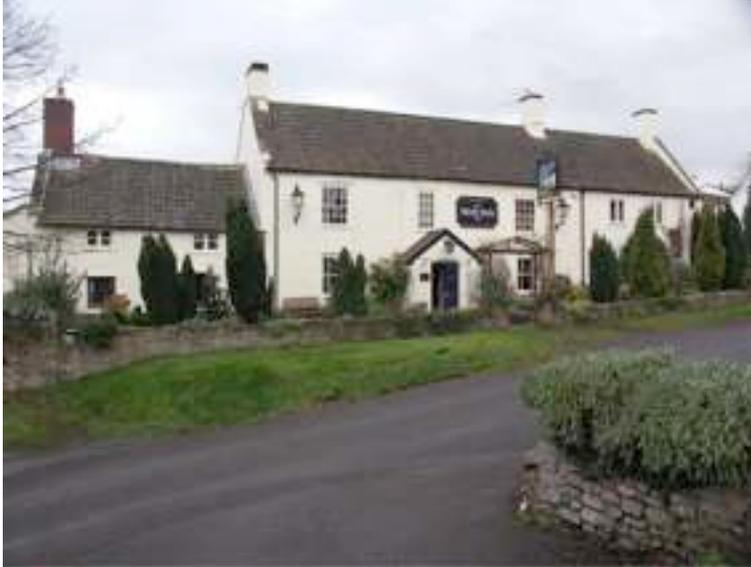
The building is comprised of three in-line elements, divided by chimney stacks, to which have been added various outbuildings and extensions (Fig. 6).

The original unit at the north end appears to have been a simple one-and-a-half storey dwelling with a single ground-floor room. On the limited evidence it seems to date from the early 17th century. The next part appears to have been built as two storeys from the outset, with two

ground-floor rooms. Although much altered, this appears to date from the mid/late 17th century. The last main part at the southern end was built as a two-storey single-room cottage, probably dating from the 18th century. Owing to so many later changes, it is not entirely clear what the function and interrelation of each unit was.

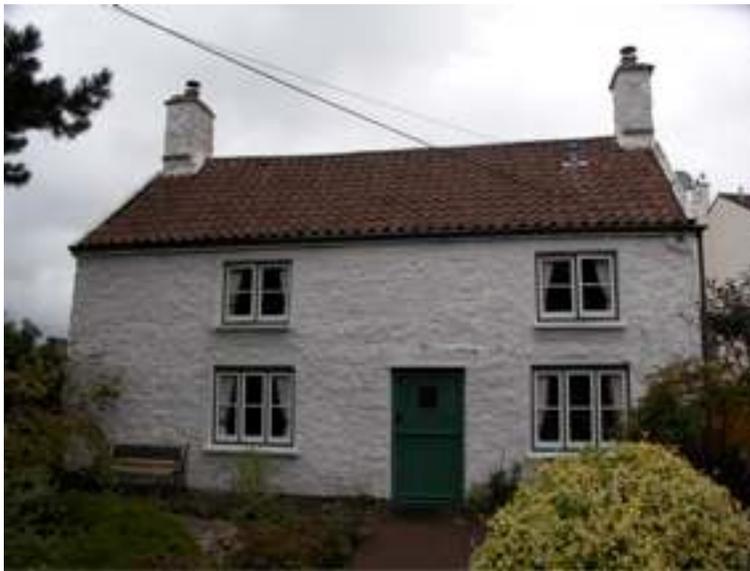
The house has an almost square plan of double-pile form (Fig. 7).

The thickness of the west wall and the slightly wider west range suggests that it is the earlier part, probably of the late 17th or early 18th century. Originally this would have comprised two units divided by a partition. The door opened directly into the living room and the smaller part

would have been an unheated service room. Possibly in the mid-18th century, the east range was added, perhaps replacing a lean-to extension. The date stone of 1727 on the south-west chimney stack cannot be *in situ* as the original building was unheated at that end. It may have been relocated when the house was enlarged.

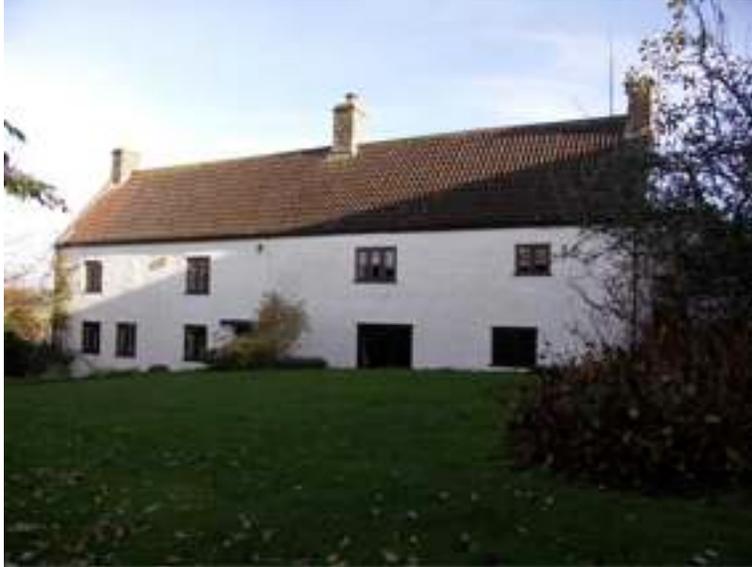
The house is two storeys with four units in line together with a staircase turret and a part-storied east wing (Fig. 8).

The original house was one-and-a-half storey comprising hall and inner room with two chambers over. The common-rafter roof and the details of framed ceiling, beams, etc. indicate an early 16th century date. This plan form including a central stair turret has been found

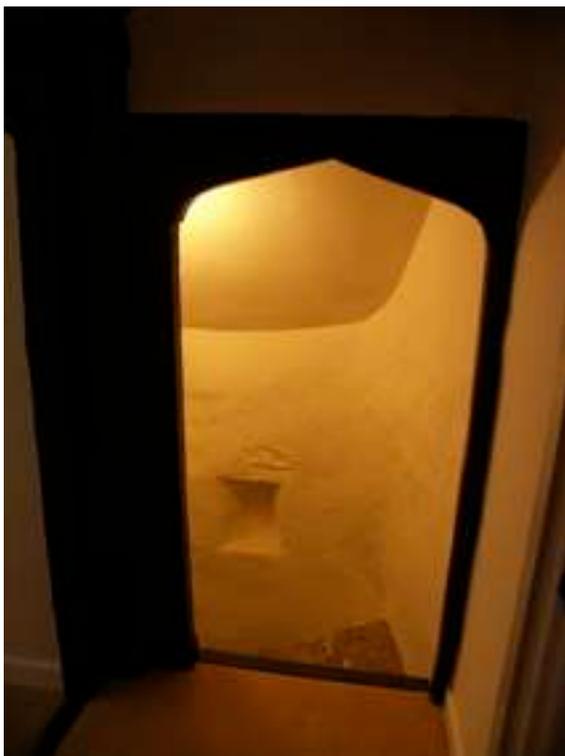
elsewhere in north Somerset (Fig. 9).

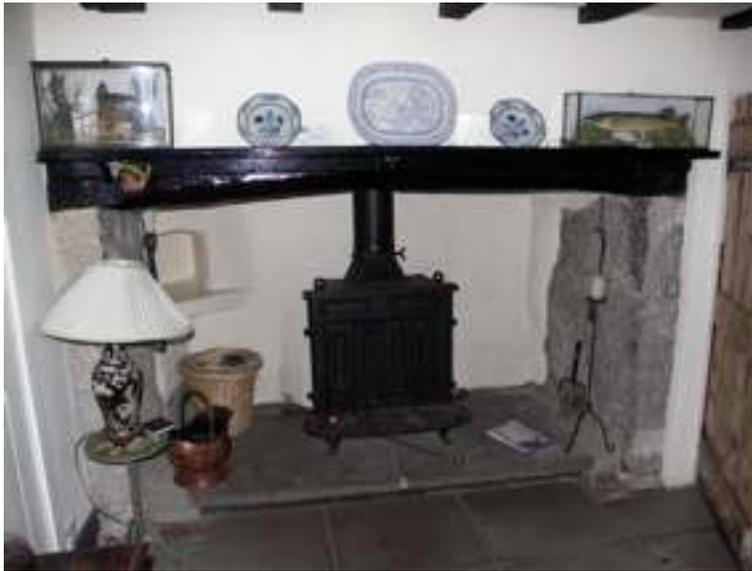
The plan is three rooms in line with an out-shut at the rear under a lean-to roof. On the evidence of construction details the core of the house dates from the early 17th century (Fig. 10).

At that time there appears to have been no cross-passage or a substantial fireplace for a kitchen, so the house probably comprised a living room, parlour (perhaps unheated) and a stair turret in the out-shut giving access to the chambers over. In the late 18th century, a room

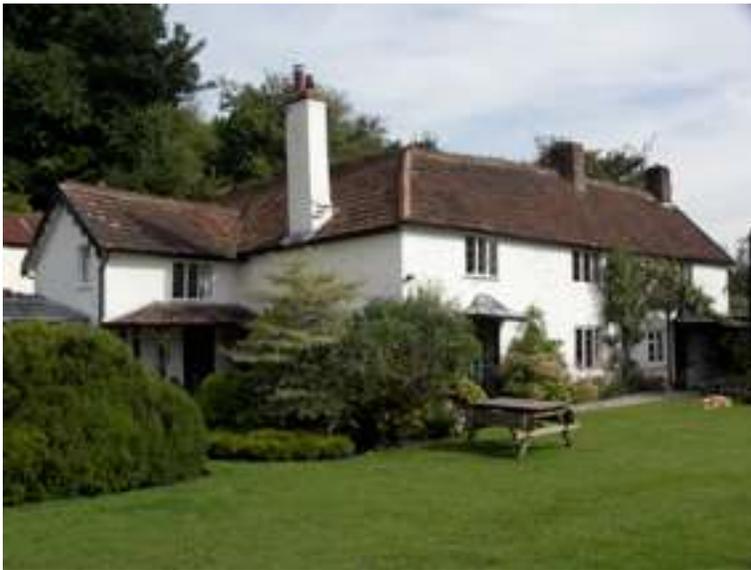
Originally this property was owned by the Dean and Chapter of Wells and sold in 1794. It stands adjacent to Wadeford Mill. The house is two storeys and the oldest part, the north-south range, appears to date from the 18th century (Fig 11).

Whether it was built as a dwelling or part of the mill complex is unclear. It lacks a large kitchen fireplace, but this might have been at the south end, which has been rebuilt. Later in the 18th century the east-west range was added. Part at the rear was probably enlarged in the early 19th

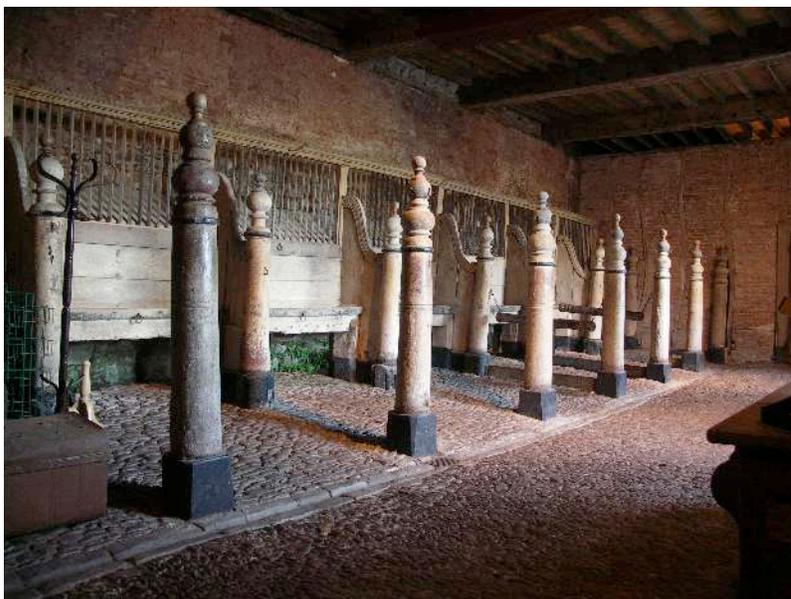
In his monograph on the *British Stable* (2004) Giles Worsley described Dunster as “Perhaps the earliest ... and most important surviving stables built for George Luttrell by William Arnold ... in about 1617”. However, this early date has been disputed by others. SVBRG were asked by the National Trust to survey this building, which is built of local rubble stone and the entire roof structure is comprised of collar-trusses. The outstanding feature is its complete interior with all the original stalls in place (Fig. 12).

From the survey of the roof, windows and other details it was possible to confirm an early 17th century date.

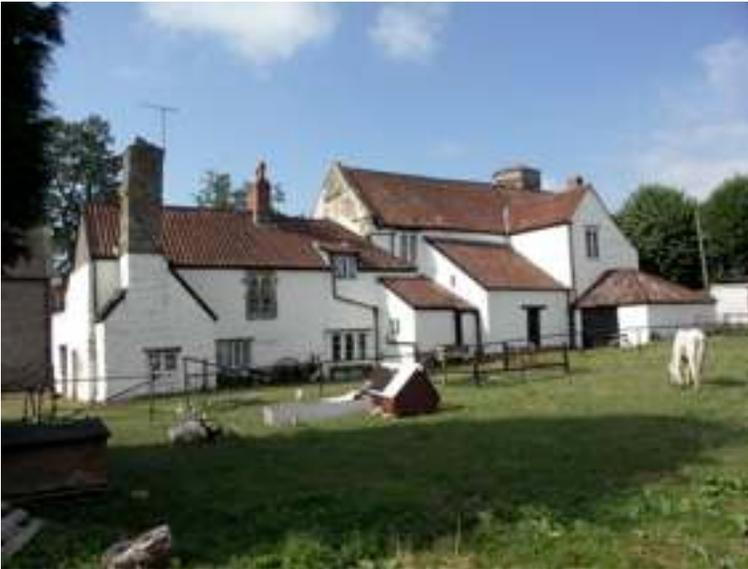
This is an important and complex house, where historical research is continuing. Interestingly, it was acquired in 1616 by Bristol Corporation who are still the owners. The Corporation revived manorial court sittings in some style in 1624, possibly in this house. The plan is comprised of two main parts, to the east, an L-shaped unit of two storeys (Fig. 13)

The eastern unit is almost certainly 15th century, originally perhaps three rooms with a cross-passage and a lateral stack. The absence of smoke-blackening of the decorative arch-braced collar roof

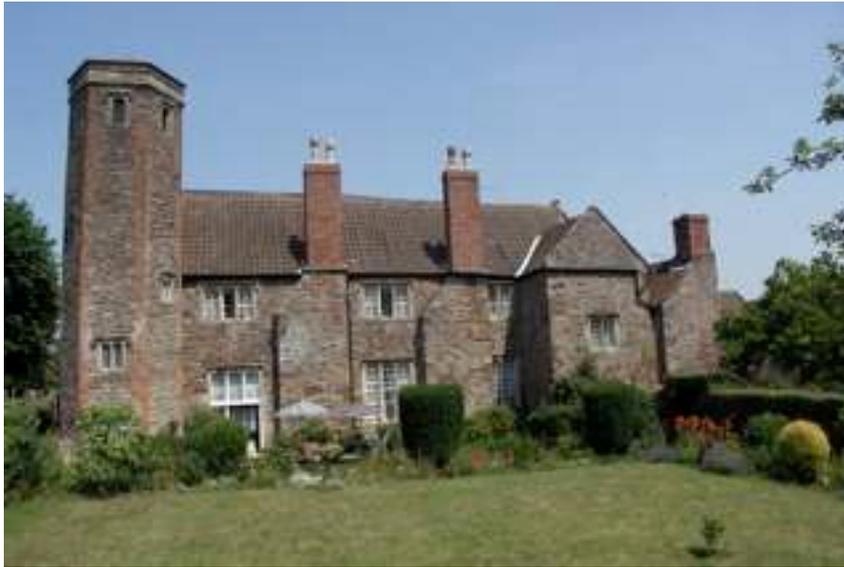
and, to the west, a larger unit of two storeys and attic, with a two-storey porch on the

south elevation (Fig. 14).

with wind-braces and cornice suggest that the upper floor existed from the outset. Further alterations took place in the 16th and 17th centuries. Regarding the western unit, the style of the roof structure and the details suggest a date in the early 17th century. For example, the use of convergent stops on moulded beams is found in Gloucestershire from the early 17th century, but is not commonly found in Somerset.

The proportions and details of this part, particularly the ceiling heights, suggest that it was not erected as a domestic dwelling. Thus it might be inferred that the builders were Bristol Corporation, who it is recorded had a grand opening in 1624. A hexagonal tower is attached to the south-west corner, built later in the 17th century. The date 1751 below the attic stairs indicates that alterations or repairs took place at that time.
