## Surveys 2010

### Aller, Lion House and The Old Rectory. ST399293.

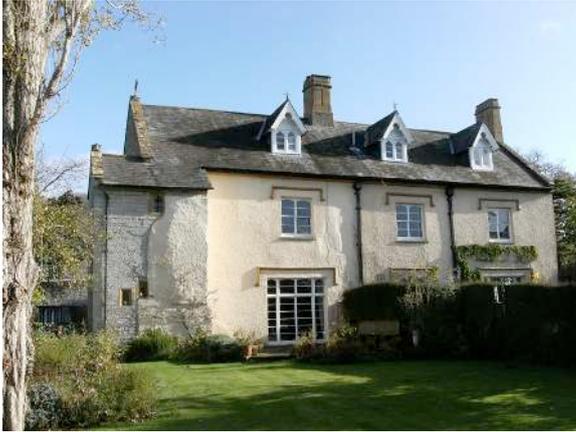
*Fig. 1. Aller, Old Rectory and Lion House, stair/garderobe turret at left hand side, (photo, John Rickard)*

A former Rectory now two separate houses. Much of the earlier building has been lost but remnants of an elaborate roof structure including arch-braced jointed-cruick trusses and windbraces, moulded beams, moulded doorways, moulded windows and early glass indicate a 15<sup>th</sup> century period of build. The north end of the house was then 2-storeys and comprised a parlour and a principal chamber over, – access to the latter being by a stair turret with two integral garderobes. The large 2-centred moulded Ham stone arch (ca.1400) may have given access to a chapel wing or an oriel. The central and southern parts of the house probably contained the hall and service rooms. A four-bay barn within the curtilage is likely to have been a Tithe Barn. It has jointed-cruick and arch-braced trusses, perhaps dating from the 16<sup>th</sup> century.

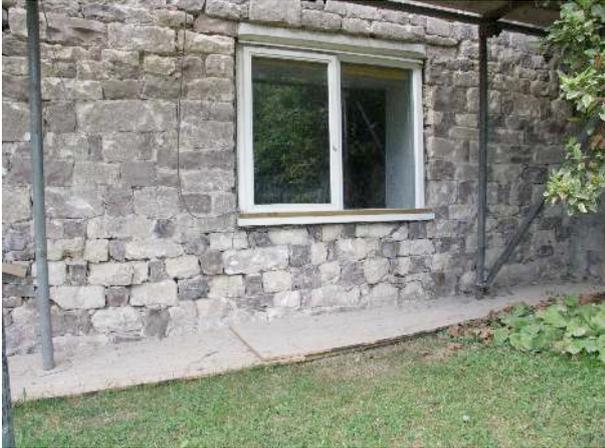
*Fig. 2. Combe St Nicholas, Chequerwork on the front wall at Fforden (photo, John Rickard)*

This house was originally surveyed by the Group in 2004. One of the features of the house was the diaper pattern of black chert and white calcareous grit on the fireplace wall in the cross passage.

In 2010 the external pebble-dash render was stripped to undertake structural repairs, particularly to the front wall of the house, and this revealed that the front wall had been built using the black and white stones to create a chequer pattern. Sadly only an estimated 15% of the wall retains this pattern, the remainder having been subject to many phases of alteration or repair.

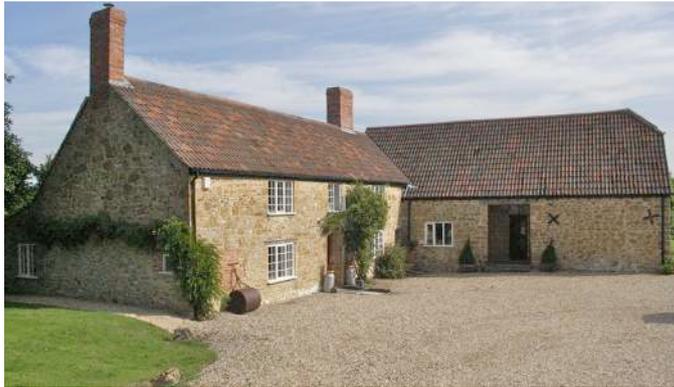
*Fig. 3. Cudworth, Ware Farmhouse, (photo, John Rickard)*

Smoke-blackened jointed-cruck trusses indicate a 15<sup>th</sup> century cob walled house which comprised an open hall (including a passageway) and service room. A rare wind-eye, shuttered internally, set high in the north wall (there had probably been another in the south wall) would have dispersed the smoke. In the 16<sup>th</sup> century a smoke-bay with oven and curing chamber was built at the west gable and, later in the century, a fireplace/stack was built in the hall and the cross-passage defined. A framed ceiling supported a first floor chamber and stairs were also built. Major changes occurred in the late 18<sup>th</sup>/early 19<sup>th</sup> century which included the rebuilding of the cob walls in stone and subsequent alterations to roof level and windows. It had been part of the Cudworth manor estate which was bought by the Earl Paulet of Hinton St George in 1791 [*'Somerset Complete Guide'*, Robin Bush (1994)]. Subsequently substantial alterations followed including the rebuilding of the S walls and the E gable and the addition of a threshing barn and water mill.

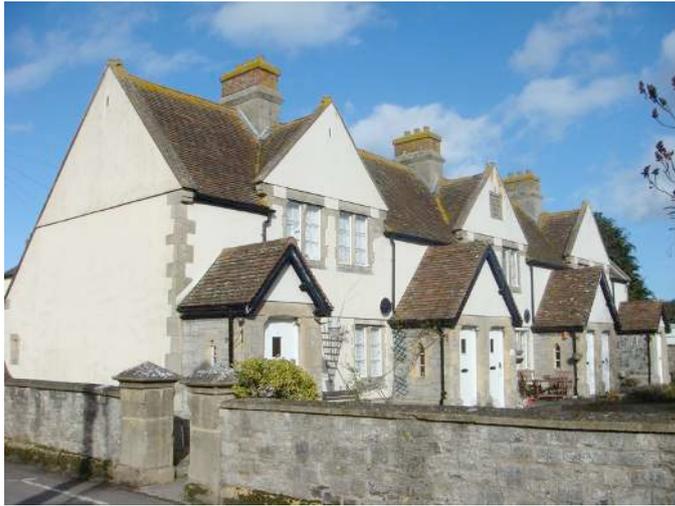
*Fig. 4. Stogursey, Lime Street almshouses. (photo, Mike Hargreaves)*

This almshouse was originally built for six poor women about 1870. The building is largely rendered, probably over local rubble blue lias stone, with ashlar quoins. It comprises six one-and-a-half storey terraced dwellings each with two rooms on the ground floor and rooms above. Alterations in 1981 extended the dwellings on the north side.

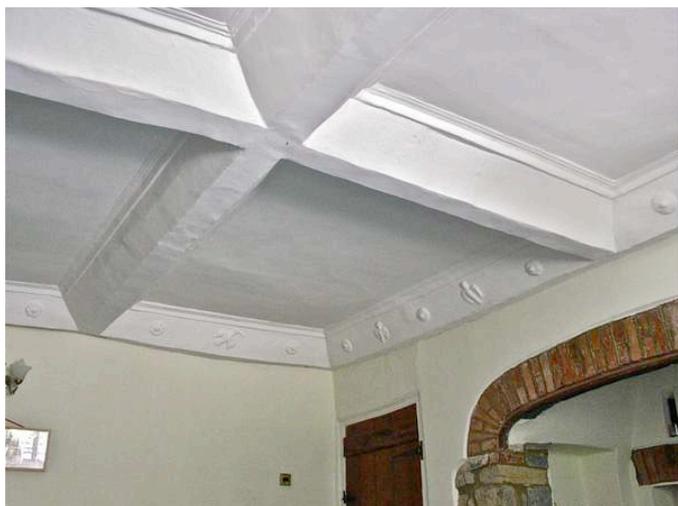
*Fig. 6. Cathanger, framed ceiling and frieze. (photo, John Rickard)*

Considered to be on the site of the capital message of Cathanger manor, it is a one-and-a half storey house built of local lias stone, now divided into two dwellings, Cleeve Cottage and Moore's Cottage. The early plan form seems to be the traditional three rooms and cross passage plan with a cross wing at the western end and later additions to the north and east. However, an earlier survey in 1994 surmised that this may be a rare example of a medieval long house with the byre at the exceptionally long 'low end' incorporating the downward slope of the land. Then the domestic accommodation would have comprised an open hall and an inner room with a solar above. Certainly the walls of the hall and the south wall of the low end have a late medieval thickness. A major refurbishment appears to have taken place in the 16<sup>th</sup> century; cooking facilities seem to have been moved to the inner room creating a kitchen, the new hall fireplace has a re-used cambered collar from a 15<sup>th</sup> century arch-braced roof as a lintel whilst a jamb on it has a half-pyramid stop. At the same time the former byre was replaced by a parlour with an impressive six-panel framed ceiling exhibiting deep chamfers and step/ogee moulding. A projecting south wing with wall thicknesses suggesting 16<sup>th</sup> or 17<sup>th</sup> century was also built, possibly as a brewhouse. General 'gentrification' occurred in the 18<sup>th</sup> century creating a drawing room in the brewhouse with a high corniced ceiling, whilst the wall beams of the framed ceiling in the parlour were plastered and decorated with a frieze depicting birds interspersed with a rose motif. On the division of the property a fireplace and oven were inserted in the parlour. No evidence of an early roof remains; the extant one dates to the early 17<sup>th</sup> century.

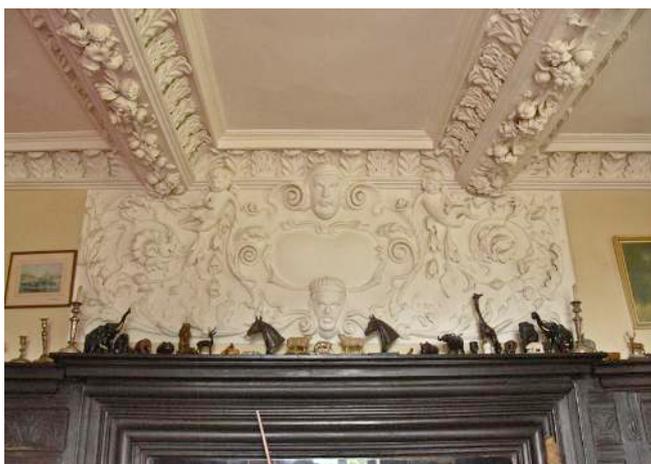
*Fig. 8. Stogursey, Steyning Manor South. Ornate plasterwork on overmantel and ceiling beams. (photo, John Rickard)*

This was built as a complete house six metres south of the old manor house. The symmetrical double-pile four-room plan is unusually progressive for the 17<sup>th</sup> century date attributed to its gabled external form and internal features. The central entrance is through a storied porch and a fine nailed door in a four-centred, moulded and elegantly stopped door frame. This probably led to a cross passage, now incorporated into a room with mid 17<sup>th</sup> century panelling and ornate high-relief plasterwork cladding to the ceiling beams and an ornamental overmantel over a bolection-moulded wooden chimney piece suggesting refurbishment in the late 17<sup>th</sup> century with good quality joinery. Double doors of a similar date separate it from the dining-parlour. This is lined with bolection-moulded panelling; the chimney piece is similar and surmounted by a painted panel. The central stair hall contains a dog-leg staircase with heavy, plain newels, turned balusters and an unusual double-height balustrade on the landing; a panelled door with an open grill at the top encloses the stair top and it and the balustrade are surmounted by two rails tipped with iron spikes suggesting a need to make this floor secure. The rooms to either side of the stair hall have four-centred arched timber moulded door frames, but the arrangement of these doors is not typical of four-room plan houses suggesting that the old house provided the service facilities.

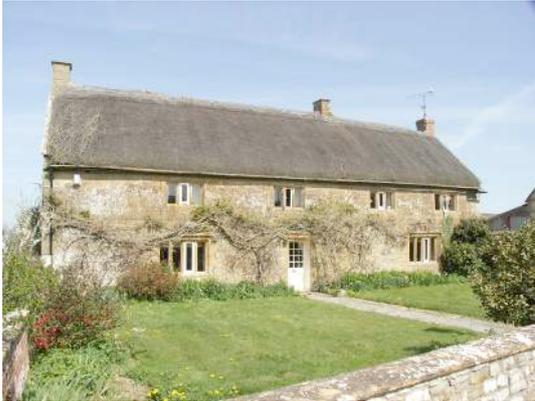
*Fig. 9. Trent, Hummer Farmhouse, (photo, John Rickard)*

A substantial multi-phase farmhouse deserving of its Grade II\* Listing. In the 15<sup>th</sup> century it was single-storey and comprised an inner room, open hall, service room and cross-passage with a lateral stack at the back of the hall and a smoke bay in the service room. There may have been a solar over the inner room. In the 16<sup>th</sup> century additional fireplaces, curing chamber and winding stairs were inserted as was an upper floor. Re-fronting also occurred including ground-floor Ham stone mullioned windows and 4-centred moulded Ham stone doorway and eye-brow dormers in the thatch roof. In the 17<sup>th</sup> century a dairy/cheese room with cheese loft was added and also servants' attic accommodation. The 18<sup>th</sup> century saw the walls and roof being raised and first-floor mullioned windows inserted. Also in this period, a cider house, apple-loft and cart-shed were added. [Note: Internally, a 12<sup>th</sup> century elaborately moulded stone doorway has probably been brought from the site of a chapel in nearby Adber]. The holding totalled 63 acres in 1839, 125a. in 1851 and 132a between 1861-1891.

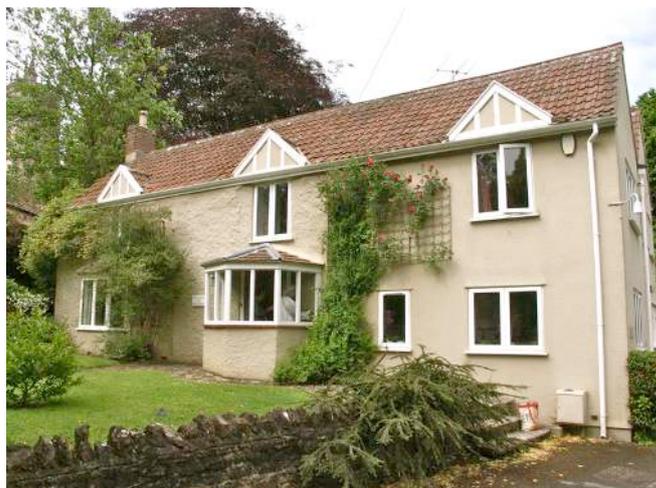
*Fig. 11. Winscombe, The Cottage by the Church, (photo, John Rickard)*

The property appears on the Dean and Chapter Map, 1792, and on the Tithe Map, 1839, as a single range. Today it is one and a half storeys high with two ranges in double-pile form. Built in the first half of the 18<sup>th</sup> century it comprised a kitchen-living room and an unheated service room. The walls of these rooms have an internal ‘batter’, diminishing in a curve from 65cm thickness at floor level to 53cm at the ceiling. This is more common in industrial buildings but the fireplace, beams and gable window lead us to suggest that it has always had a domestic purpose. The rear range dates from the mid 19<sup>th</sup> century with external quoins and window openings constructed in brick. The original range was probably re-roofed, and clad in double Roman tiles, to accord with this and the thatch removed. More modern, cavity wall, extensions with a floor level some 50cm below the rest of the building allow for the down hill slope. The front elevation is enhanced by three small gables over the first floor windows. The walls are part rendered and colour washed.

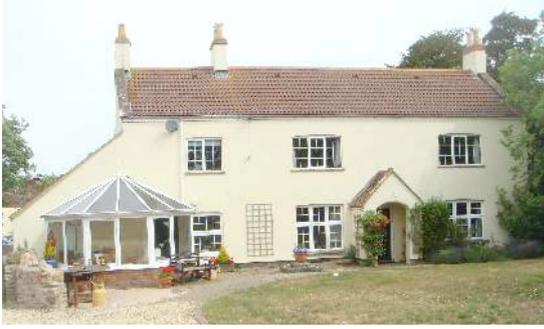
*Fig. 19. Winscombe, Sandford House, south elevation, (photo, Mike Hargreaves)*

The house has a two-storey main east/west range with a lean to on the west and a two storey northern wing set at an angle to the main range. The house is rendered over local random conglomerate stone walls and the roof is clad with pantiles. The gabled ends of the main house are finished with Hamstone coping stones a former single-storey farm building has been partly incorporated into the house. It originated as a two room central entry house in the late 16<sup>th</sup> century, extended to the west in the early 17<sup>th</sup> century. Alterations in the late 18<sup>th</sup>/early 19<sup>th</sup> centuries included the rear wing and major new internal arrangements.

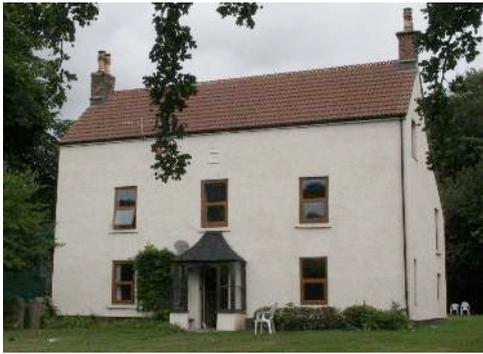
*Fig. 20. Winscombe, Dalecroft south elevation (photo John Rickard)*

This two and a half storey house has a one and a half storey lean-to under a catslide roof to the rear. The windows are arranged in a symmetrical manner and above the central upper window is a datestone for 1811. Until 2005 the house had a thatched roof but all the main roof has been replaced. The remaining roof of the catslide has tusk tenoned purlins signalling late 18<sup>th</sup> /early 19<sup>th</sup> century construction. The upper floor is reached by stairs in a rear hall which have a generously dimensioned turned newel and balusters stylistically belonging to the late 19<sup>th</sup> century. This stair is thought to replace a straight flight when a small extension was added to the rear. It is likely that fireplaces and doors were also replaced at this time. Access to the attic space was through a door in the rear wall of the main range reached by a stair now gone. The attic walls were all plastered and the space appears to have been undivided indicating its use as storage space rather than accommodation. An outhouse containing a pump, stone trough, and large fireplace with a three-centred wooden lintel arch provided wash-house and baking facilities and is thought to date, by its slightly thinner 45cm walls, to the mid 19<sup>th</sup> century.

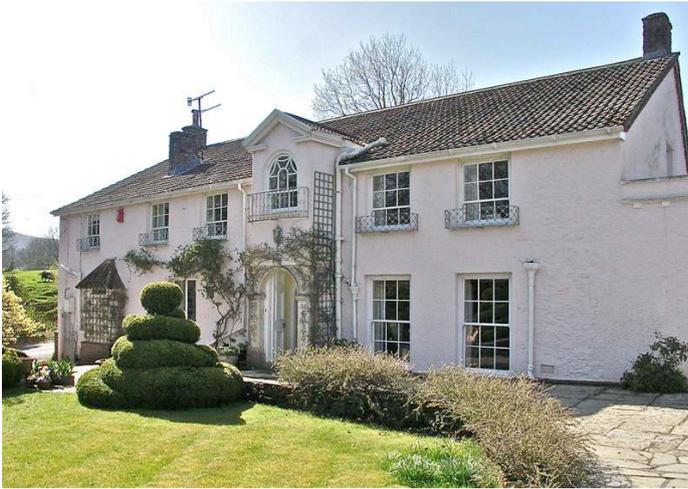
*Fig. 12. Winscombe, Watcombe, 92, Church Road, (photo, John Rickard)*

The house is of two storeys and has three rooms in each of two parallel ranges. All walls are rendered and the roof is clad with double Roman tiles. The house has been extensively changed. It appears to have originated as a mid 18<sup>th</sup> century, one and a half story dwelling which is evidenced in one remaining room, which probably had a lean-to against the north wall. At this time it was probably thatched. Shortly after construction the house was extended with a further room and lean-to against the east gable and this was further extended in the C19<sup>th</sup>. Later there were significant alterations to the north range, raising the eaves and providing an upper floor over the lean-to. In the mid C20<sup>th</sup> the building underwent a major refit and upgrading to create the house much as seen today, including the installation of features like the north porch, larger windows and the enlargement of rooms by the removal of walls.

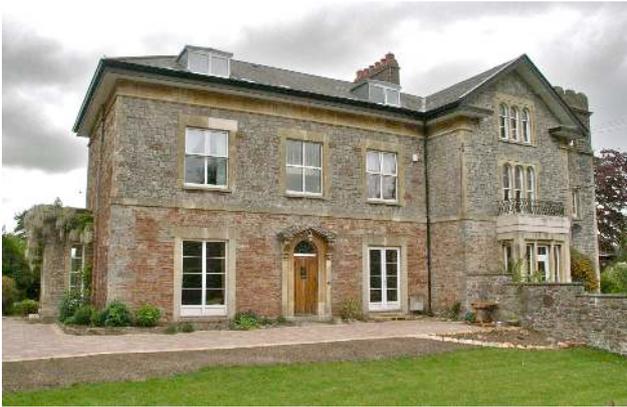
*Fig. 13. Winscombe, Springfield to left Tower House to right, originally one house. (photos John Rickard)*

This Italianate style villa has a cross-wing that breaks with the symmetrical style of earlier villas. The builder has also introduced a colour variation by using the red conglomerate sandstone (possibly from an earlier building on the site) up to the string and grey carboniferous limestone above, topping it off with a plain Bath stone frieze, which matches the window dressings, just below the deep eaves. The windows to the cross-wing are round headed on the upper floors and the top floor rooms were for servants. The original plan shows three ground-floor rooms fronting the road and a kitchen behind the probable library in the cross-wing. The stair hall in this house is surprisingly narrow. The 1792 and Tithe maps show a house on the plot, however in 1850 the house was purchased by Thomas Fry and it seems he demolished the existing property and built Springfield. The tower is made of un-squared limestone and was probably added after a new owner arrived in 1910. The house was divided in 1954, the northern part being named Tower House.

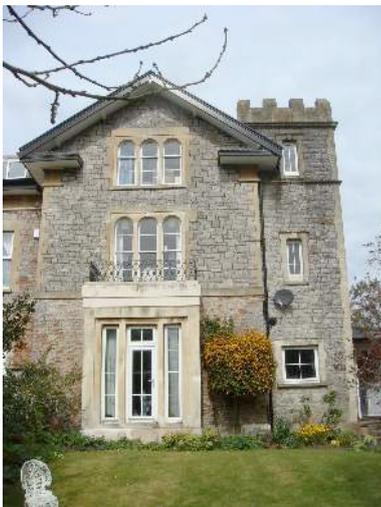
*Fig. 14. Winscombe, Tower House, now a separate dwelling, (photo, Mike Hargreaves)*

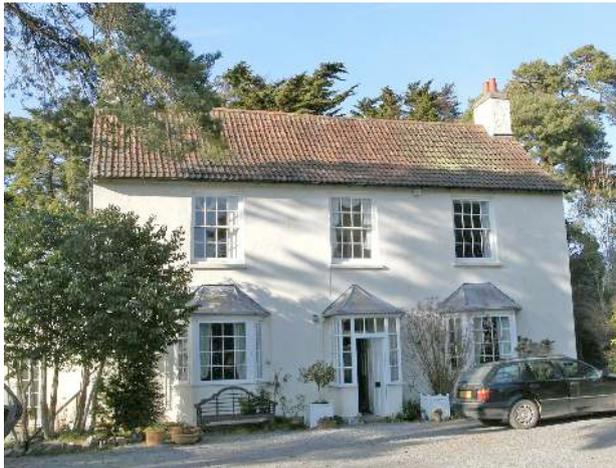
*Fig. 15. Winscombe, Longfield House south elevation (photo, John Rickard)*

The two-storey house has a symmetrical south front of six-over-six sash windows on the upper floor and a pair of canted bays either side of the front door. There is a full height wing on the rear creating an L-plan. A one and a half storey lean-to fills the remainder of the north wall. An open-well staircase with quarter landings has a simple newel, stick balusters and a ramped mahogany handrail. Ceilings at 3m height in the principal lower rooms and 2.75m on the upper floor give an airy feel to the interior. The lean-to provided servant accommodation over a scullery or wash house and was fitted with a narrow stair. The roof structure is of oak tie-beam trusses with tenoned apices and two tiers of butt purlins. This roof is unusual because it is oak whereas almost all houses in this area at this period are of elm; also that is a 17<sup>th</sup> century style of construction. The house is likely to have been built for a prosperous family and its decorative and constructional features suggest a late 18<sup>th</sup> century date. This is supported by the map prepared for the Dean and Chapter of Wells that shows nothing on the site in 1792 but a building is shown on the Tithe Map of 1839

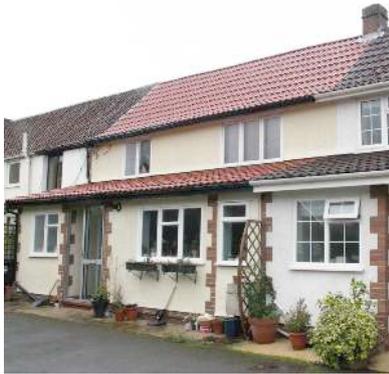
*Fig. 16. Winscombe, No 11 in centre and 10 to left (photo, John Rickard)*

The photo mainly shows number 11, with recently tiled roof, which now has a lean-to extension on the front elevation. These two one-and-a-half storey properties are in a short terrace of double pile plan dwellings with each range being of the same dimension between front and back walls and having the central and exterior walls of the same thickness. Although under two roof ranges, these two properties have interlocking L plans and seem to have gables offset by about 2.5m. In No.10 the roof structure of the rear range has a diagonally set ridge-piece and partially staggered purlins with mortice and tenon joints, suggesting late 18<sup>th</sup> century construction. All the other roofs have been replaced over time. Documentary records reveal that the residents of the Poor House, which stood close to the church, were moved to this site in 1799 which was devoid of buildings according to the 1792 map. It is possible that a building was here by about 1795 and that it was developed to accommodate the fourteen Poor House inhabitants. The simplest arrangement would have been to have seven one-up-one-down units in each range but it is unclear how that can be linked with the current division of the terrace. In 1838 the Poor were transferred to the Union workhouse at Axbridge.

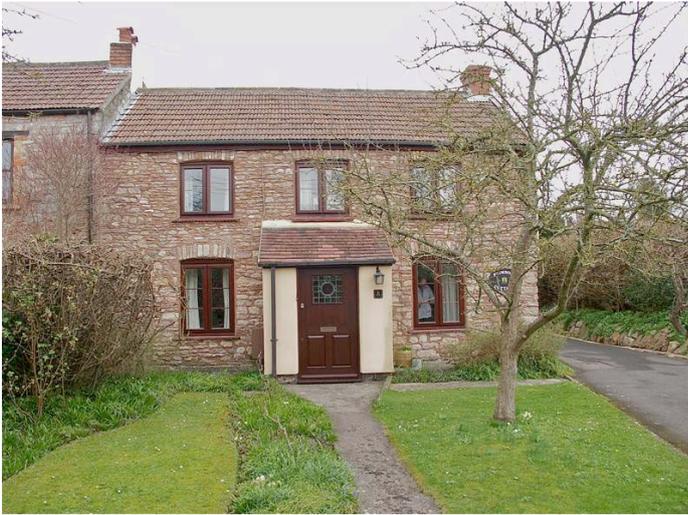
*Fig. 17. Winscombe, Primrose Cottage front elevation, (photo, John Rickard)*

The house originated as a two-storey, two-room, central entry house (possibly created from an earlier outbuilding) under a shallow pitched roof of mid to late 18<sup>th</sup> century construction. A similar sized early 20<sup>th</sup> century range is at the rear and there is a further single storey addition. The front elevation is of exposed masonry showing a random rubble wall of local conglomerate stone with shallow arched heads to window openings. The rear range is brick built.

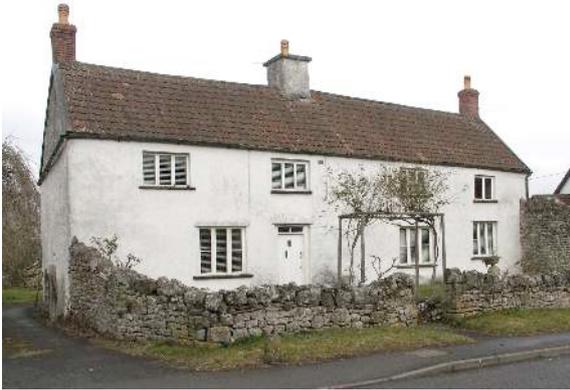
*Fig. 18. Winscombe, Walnut Tree Cottage front elevation, (photo, John Rickard)*

The house was built as a one and a half storey three-unit cross-passage dwelling in the 17<sup>th</sup> century. The rear doorway is typically wide and has an ovolo moulded frame and above is an ovolo mullioned three-light window from that period. In the rear lean-to, which is of later date than the house, there is a cross-planked and chequer-pattern nailed door on long strap hinges which may have been the original front door. In the late 18<sup>th</sup> century the hall and inner room were remodelled, raising the ceilings. The gable wall of the inner room was panelled overall with frames and fielded panels behind which were a full set of cupboards; a fireplace, now reduced to a small tiled hearth, is in the centre. The current stairs, replacing the original stairs near the main fireplace, are a straight flight situated in the cross passage and were probably inserted in the 20<sup>th</sup> century when the house is known to have been in dual occupancy.
