## BUILDING RECORDING IN 2004

SOMERSET VERNACULAR BUILDING RESEARCH GROUP

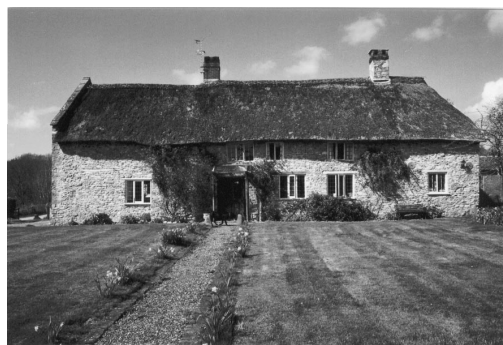
Fig. 2 Bartletts House, Wambrook; photograph John Rickard

The jointed-cruck truss and smoke blackening indicate that originally there was an open two-bay hall extending from the south end to the present stack. Presumably there would have been a service room or rooms, probably sited in the area subsequently occupied by the fireplace, stack and cross-passage. Based on similar jointed-cruck trusses in Somerset dated by dendrochronology, a date in the 15th century is suggested for the original phase. The house was extended and upgraded in the late 16th century to provide a hall, cross-passage, kitchen, outshut and fireplaces, including a curing chamber. A stair turret to the upper floor was added and the hall and hall chamber provided with mullion windows.

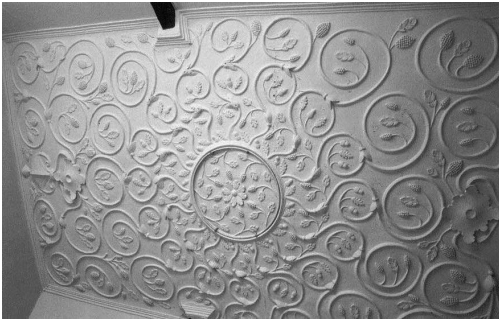
village inhabited in 1327 and probably deserted in the 16th century. The two-storey north wing probably dates from 1583 and was part of a high status house, most of which has now gone. Its impressive plasterwork (Figs 3, 4) is illustrated in *Decorative Plasterwork in the Houses of Somerset 1500-1700* by John & Jane Penoyre (1994). The main range was built or rebuilt c. 1614 and comprised a hall, cross-passage, inner room and kitchen and service stairs rising to the attics. The house was remodelled with the addition of second-floor bedrooms served by a turret stair and the full-height porch dated 1672. Elaborate surviving door surrounds (Fig. 5), doors and door fittings throughout were probably installed at this time. Weston Farm was still thatched when it was recorded in *Country Life* in September 1949. The attached Dairy Cottage probably dates from the early/mid-17th century and the nearby Chapel Cottage (Fig. 6) was originally the late-medieval chapel to the manor house.

Fig. 3 Weston Farm, Wambrook, ceiling of first floor chamber; photograph John Rickard

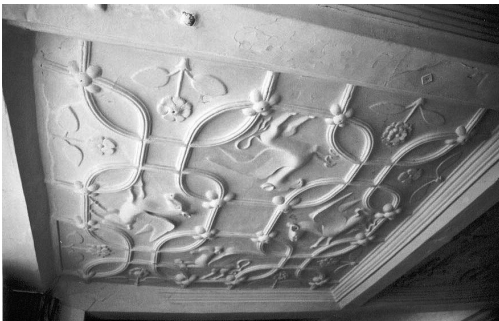
Fig. 4 Weston Farm, Wambrook, one of four ceiling panels in ground floor room; photograph John Rickard

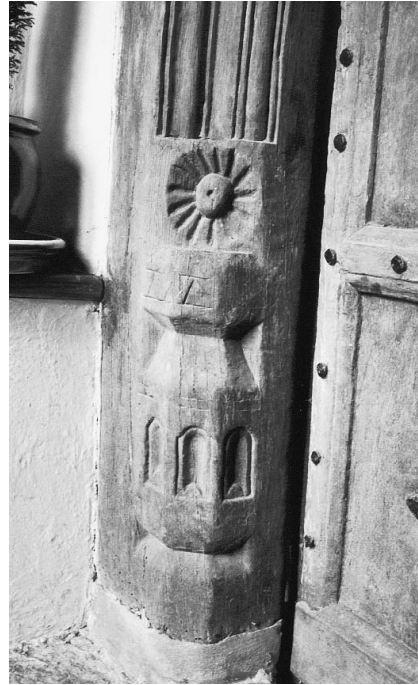
Fig. 5 Weston Farm, Wambrook, door jamb; photograph John Rickard

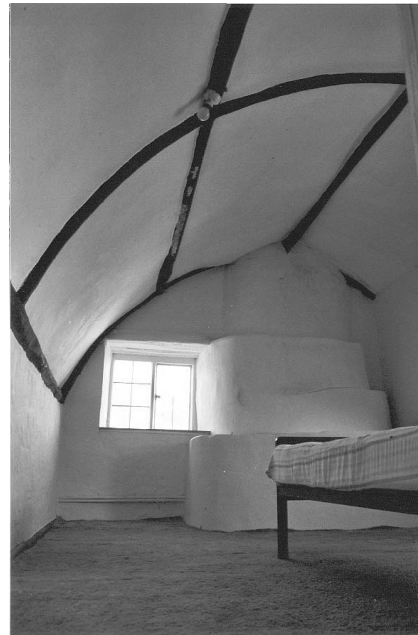
Fig. 6 Chapel Cottage, Weston Farm, Wambrook, ceiling; photograph John Rickard

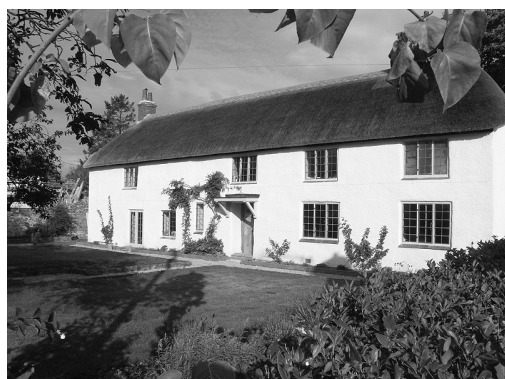
Fig. 7 Arden Cottage, Long Street, Williton; photograph Paul Upton

The surviving evidence indicates that this was a single-storey open-hall house, as there is smoke blackening of the presumed true-cruck roof and as this is earlier than the west end a date in the 14th/15th century is suggested. The jointed-cruck truss at the west end can be dated to the 15th/16th century by comparison with similar examples which have been subject to tree-ring dating. The limited amount of smoke blackening in the roof suggested that this part was added, perhaps as a byre, while the hall remained open. The details of the beams indicate that the upper floors were inserted in the early 17th century. At the same time a large fireplace at the west end was installed with a corn-drying kiln and oven. The north wing was added in the 18th century and a large oven was inserted in the former kiln. Its size indicates that this was for a commercial bakery, which necessitated the re-positioning of the kitchen in the north wing. Major work was undertaken in the early 19th century and a further rear extension added in the 1920s.

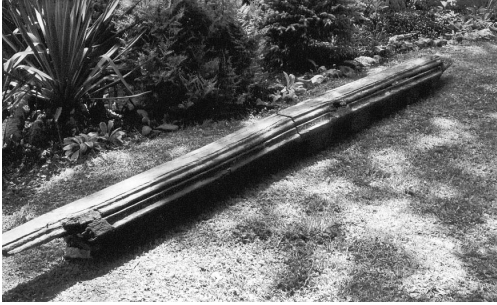
The limited evidence suggests a cob-built two-unit house dating from the late 16th or early 17th century. The house was extended in brick in the early 19th century.

Fig. 8 Ile Cottage, Combe St Nicholas, moulded beam removed during the raising of the ceiling height; photograph John Rickard
