BUILDING RECORDING IN 2008

SOMERSET VERNACULAR BUILDING RESEARCH GROUP

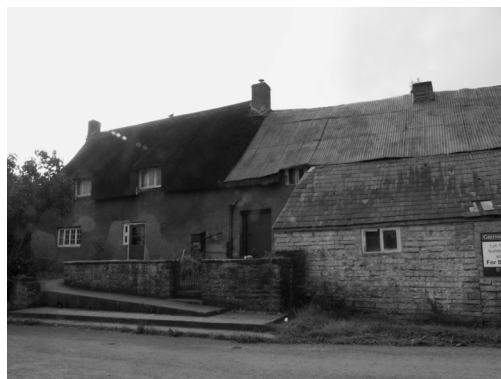
Fig. 1 High Ham, Henley Farm

The house (Fig. 1), which was formerly part of a farmstead, comprises three rooms in line with a cross-passage. On the evidence of the details of the roof construction and the smoke-blackened timbers it is probable that this was a single-storey, late-medieval open-hall house. The roof has five equally spaced jointed-cruck trusses, one with carpenter's marks. A 15th-century date is suggested based on comparisons with similar trusses which have been dendro-dated elsewhere in the county. The walls may originally have been entirely of cob and the thatched

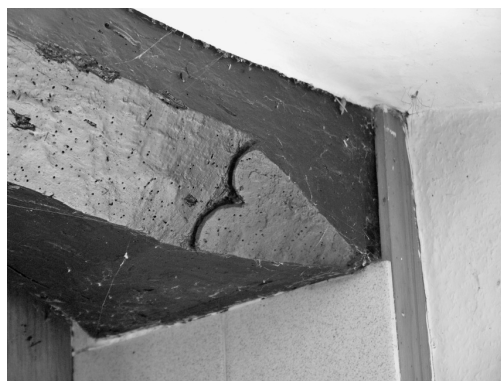
Fig. 2 High Ham, Henley Farm, detail of beam stop

roof is likely to have been hipped at both ends. The details of the beams and the stops on the chamfers indicate that a first floor was inserted about 1600. Heart-shaped stops (Fig. 2) were used on the beams in the main rooms and simpler step and run-out stops in the dairy, cross-passage and the kitchen. The fireplaces and stacks were also inserted at this time, as were dormer windows at the level of the eaves. The house then comprised a hall, heated inner room, dairy, cross-passage and kitchen. Post and panel partitions were erected on the first floor to create smaller rooms. Perhaps in the 18th century the east end of the roof was raised and dormer windows inserted. The cob walls may have been replaced or refaced using local Lias. Possibly at the same time, the house was divided into two dwellings. In the early 19th century the ancillary buildings – cider house (formerly with an apple-loft above, now gone), threshing barn (complete with surviving wooden plank threshing floor) and wagon house – were built together with lean-to additions at the front. Stables

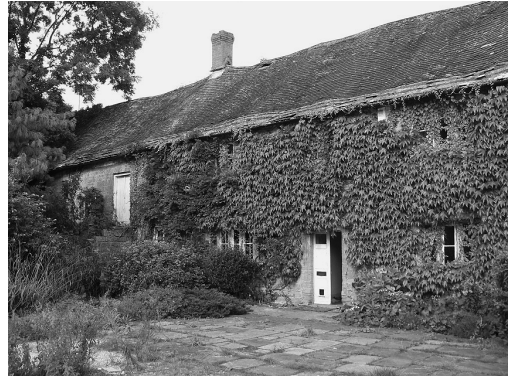
Fig. 3 Merriott, Bow Mill (left) and Mill House

The mill and attached mill house (Fig. 3) stand in an isolated position near the eastern boundary of the parish. The mill-leat is fed by a stream rising to the south-west of Merriott village and after passing through the mill flows into the River Parrett. The history of the mill is described in VCH, volume IV (1978). The house is of two storeys, L-shaped in plan and the front range is of two units, hall and kitchen, with a central cross-passage. Based upon the plan-form and details of the beams and doorway, it appears to date from the mid 16th century. The east wing may also date from this period, but was upgraded or extended in the 17th century. A new staircase hall was created and the present stairs built in the late 18th century. At the rear, a bake-house and malt-house, including a large drying kiln, was in existence by *c.* 1800. A fire in 1862 appears not to have affected the main house but was confined to the bake-house, flour loft and kiln, as the upper part of that building was removed altogether. The mill machinery is the subject of a separate detailed report by Martin Watts. In summary, his conclusions are that the machinery of Bow Mill represents an important survival as it is largely intact. There is documentation for the supply and installation of the waterwheel (Fig. 4) by Coombs of Beaminster, Dorset, in 1849–50 and it is of interest that the water feed arrangement was upgraded, perhaps in the 1880s. In addition, some parts of the machinery are older, probably late 18th or early 19th century. The arrangement is fairly conventional with three pairs of millstones (Fig. 5). The survival of two ancillary machines for producing animal feed, the completeness of the millstone furniture and the survival of some artefacts associated with stone milling are also considered important.

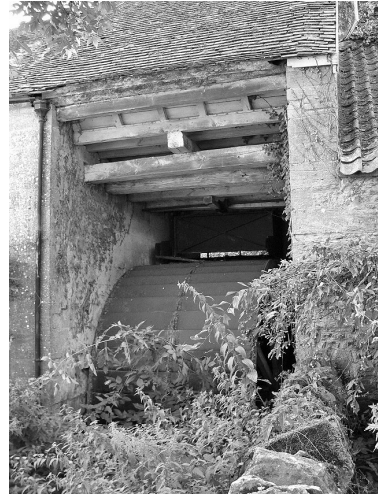
Fig. 4 Merriott, Bow Mill, wheel chamber and waterwheel

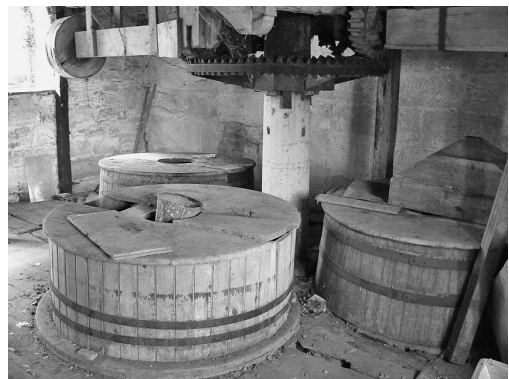
Fig. 5 Merriott, Bow Mill, stone floor with tuns (cases) and three pairs of millstones.

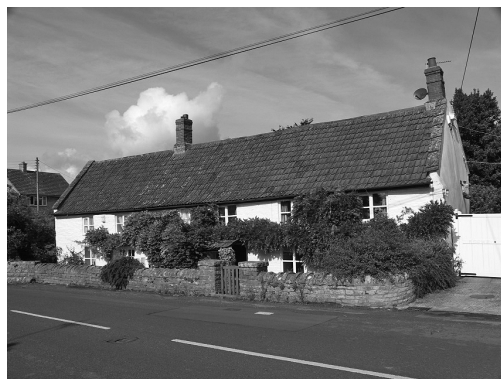
Fig. 6 Somerton, Roche Bridge Cottage

The house (Fig. 6) has an essentially rectangular plan comprised of three units with the southern part set at a slight angle. The misaligned unit is known to have been a stable in the 20th century, although now adapted as living accommodation. The earliest part of the house appears to date from c. 1600, based upon the single surviving collar truss, and at that time probably comprised one room with gable entry. There is an outshut to the rear and a curing chamber is located next to the inglenook fireplace. A second room was probably added in the mid 17th century. It appears that for a period the house was divided into two dwellings.

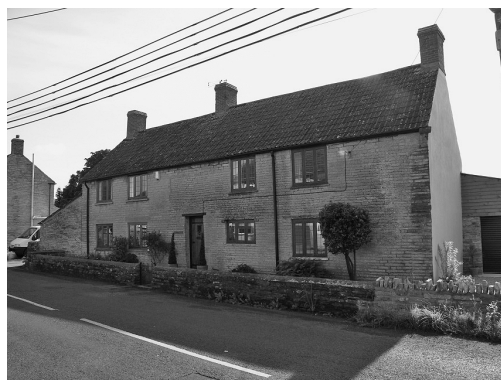
Fig. 7 Somerton, Springfield Farm

The house (Fig. 7) is of two storeys with three rooms in line and a cross-passage. A date in the late 16th century is suggested by the thickness of the walls and details of a fireplace and the poor quality roof over the hall. The roof, with tie and collar trusses, over the rest indicates that the house was upgraded later, perhaps in the early 17th century. Adjacent to the kitchen fireplace are the remnants of a substantial curing chamber and what may have been a small corn-drying kiln, perhaps converted to an oven. It is likely that the walls and roof were raised in the late 19th century and part of the front wall refaced. It is probable that the south-east wing – formerly farm buildings, a barn and cider house – was added at about this time. This wing has since been incorporated into the house.

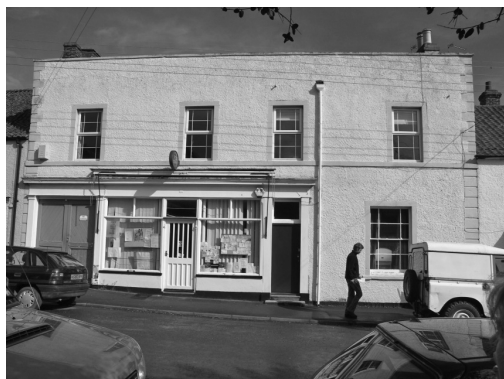
Fig. 8 Stogursey, High Street, No. 16

The two-storey, double-pile plan was probably a pair of cottages dating from the early 19th century, with two rooms on the ground floor and adjacent through passages (Fig. 8). The cart-way gave access to a courtyard with service buildings. The cottages were combined in the mid 19th century, when rear additions were built and the eastern through passage was built over. In the 20th century the Post Office accommodation has taken up the ground floor of the west cottage and the front room of the eastern one.

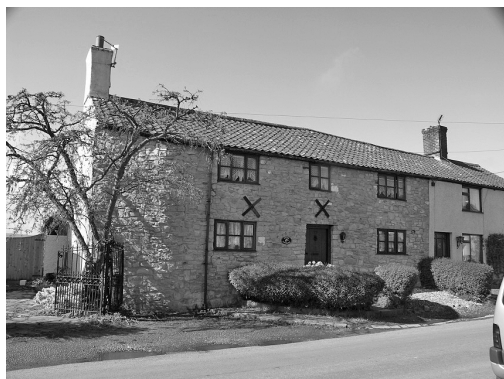
Fig. 9 Stogursey, High Street, No. 23

It appears that the original house had a two-room, gable entry plan (including part of what is now the adjoining property) (Fig. 9). The evidence of surviving details indicates a date in the 16th century and it appears to have been of some quality. In the mid 18th century it was extended to the east with a cross-passage and service room, and later additions to the rear.

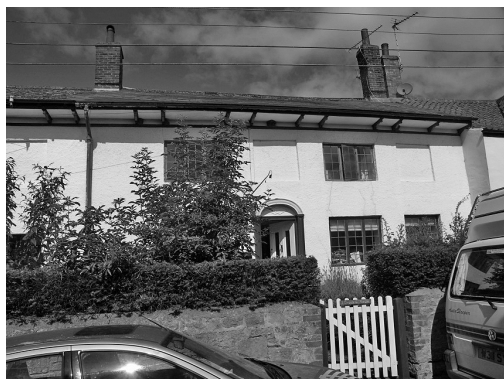
Fig. 10 Stogursey, St Andrew's Road, Cross Cottages, Nos 1 & 2

The houses (Fig. 10) are conjoined and attached to No. 1 St Andrew's Road, and comprise four rooms in line. The jointed-cruck truss together with the half-pyramid stops on the beams indicate that Cottage No. 1 probably dates from the late 15th or early 16th century. It then comprised a hall and unheated inner room, with a turret stair. In addition, the numbering of the carpenters' marks shows that there would have been three further bays to the south, presumably including a cross-passage and service room. Details of the hall fireplace suggest a 17th-century date, which probably indicates that it replaced a timber fire-hood. By the time of the 1841 Tithe Map, the property had been divided into two, and the 1886 OS map shows it further divided into four single-room units, each with a rear outlet. It reverted to two dwellings in the 20th century.

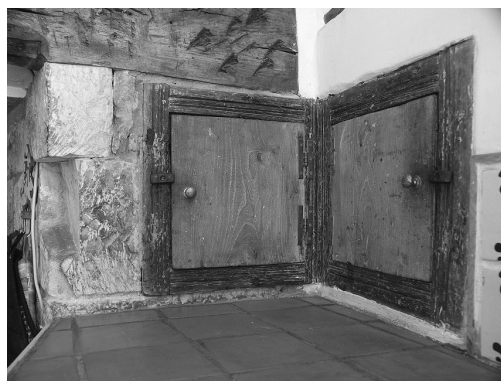
Fig. 11 Stogursey, Shurton, Fisher's, spice cupboards

Based on the details of the beams and roof structure, a late 16th century date is suggested. Then it comprised a hall with the stack backing onto a cross-passage, and a service room, the latter probably with a timber fire-hood and curing chamber. This plan form is relatively rare in Somerset (although Myrtle Farm, Shurton, is another example – see *SANH* 151 (2008), 196). However, the presence of a closed truss over the kitchen is an anomaly and it is possible that there may have been an earlier plan form. Two small spice cupboards (Fig. 11) next to the hall fireplace are an interesting survival. In the 17th century, a stone stack was inserted within the fire-hood, and in the 18th century the west end was extended. The barn (now a dwelling, Brookside) and the lean-to

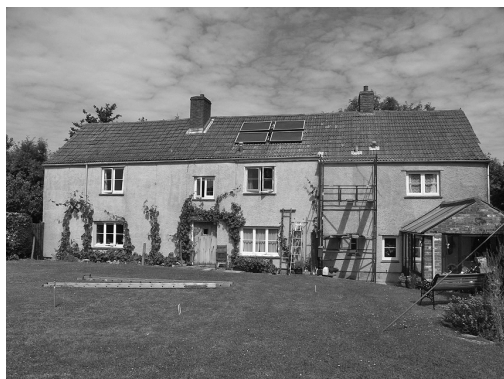
Fig. 12 Stogursey, Shurton, Fisher's

additions were added at this time. The walls, roof and windows were raised in the mid 20th century (Fig. 12).

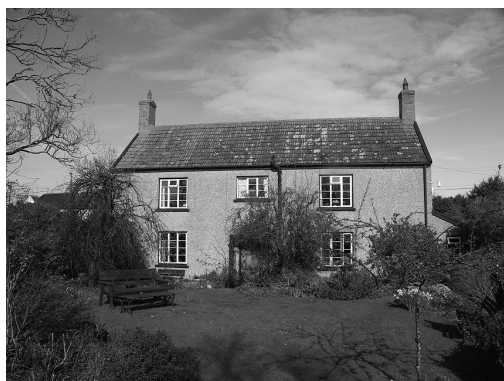
Fig. 13 Stogursey, Shurton, Grove House

The house (Fig. 13) is essentially a two-room plan with entrance and stairs between, built in the late 18th century – possibly in 1782, when the owner George Grove paid Land Tax. Two rooms were added in a single storey at the rear, possibly at differing times, but shortly after the original build. A further lean-to was added later to the east.

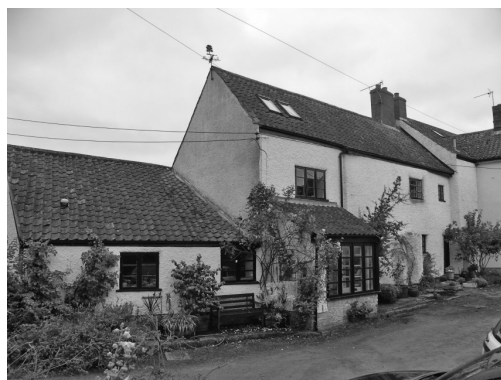
Fig. 14 Stogursey, Shurton, Old Mill House

The main range comprises four rooms in line with an addition at the end (Fig. 14). The original house, probably dating from the mid 16th century, comprised a hall with a small unheated inner room,

with entry in the then north gable end. A single unit was added c. 1600 as a hall/kitchen and the original rooms were combined and upgraded to become a parlour. A fourth room was added in the 19th century as a working kitchen. Later the house was divided into two. The far end addition was originally open, but incorporated into the house in 1993. An associated cider house was sited across the yard. The attached mill is situated on the Stogursey Brook to the east of Shurton. No remnants of the mill machinery survive and the whole has been converted to domestic use. The history of the ownership is recorded in VCH, volume VI (1992).

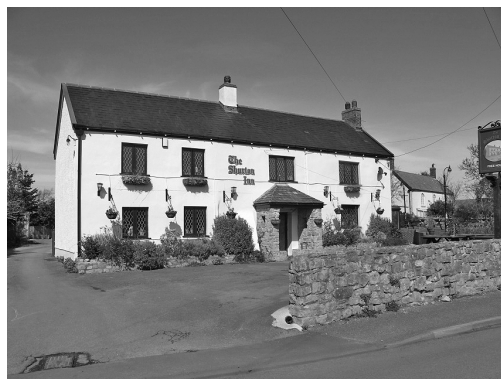
Fig. 15 Stogursey, Shurton, Shurton Inn

The front range appears to have been built *c.* 1600 and then comprised the hall, unheated inner room, cross-passage and kitchen with curing chamber. The Tithe Map of 1841 shows that a wing at the rear had been added, perhaps as a service room. In 1862 it became an inn (VCH, volume VI (1992)) (Fig. 15) and at about that time the roof was raised and further lean-to additions built.

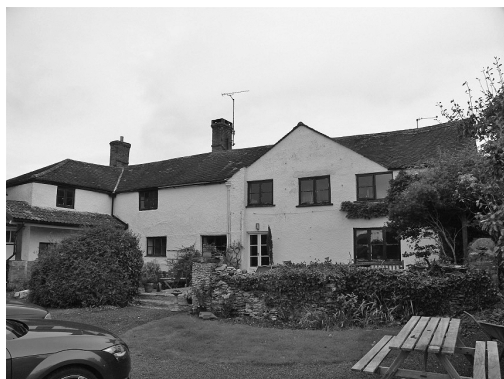
Fig. 16 West Monkton, Blundell's Farm

On the evidence of the wall thickness and the smoke-blackened roof timbers, it is considered that the house (Fig. 16) was originally of late medieval build,

probably in the mid 15th century (based on similar dendro-dated examples). It had then a single-storey open hall with a jointed-cruck roof, but the full extent of the building cannot be determined from the surviving evidence. However, it is likely to have comprised a service room, two-bay hall, and perhaps another room at the east end. In the mid 16th century, fireplaces, stacks and a first floor were inserted. Then the house comprised a kitchen, cross-passage, hall and an unheated inner room. In the third quarter of the 19th century a south wing was added, perhaps as a parlour. This was demolished *c.* 1900 and the house was extended to the east. The adjoining barn is built entirely of cob, so it is likely that the house also contains some cob.

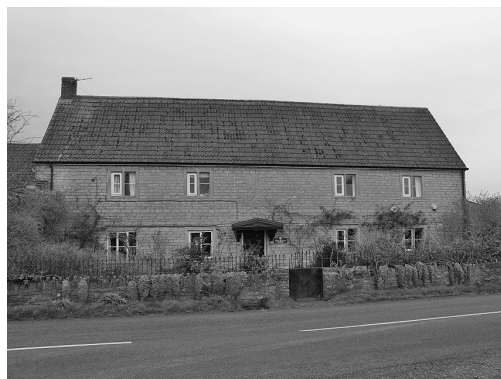
Fig. 17 West Pennard, Penwood Farm

The two-storey house with attics is detached and formerly was part of a farmstead (Fig. 17). It has a three-unit with cross-passage plan and a two-storey wing and lean-to additions. The proportions and details suggest that the occupier was of yeoman status. On the evidence of details and the roof structure, a late 16th-century date is suggested. The house then comprised a kitchen with ovens and curing chamber, cross-passage, hall and inner room. An attic over the kitchen and cross-passage afforded servants' accommodation as well as possibly being used as a cheese-loft for part of the year (this arrangement is similar to that at nearby West Town Farm, Baltonsborough). On the front elevation there is a date-stone for '1723' indicating when the house was substantially upgraded: the walls and roof were

raised, the east front refenestrated and a two-storey parlour wing added. In the 18th century there were further additions, including a dairy. By the time of the Tithe Apportionment (1841) the holding was a dairy farm with *c.* 40 of a total of 42 acres being pasture, the remainder being cider orchards.
