The use of the Golden Triangle in Somerset building design.

This document considers the possible use of the Golden Triangle in the construction of Somerset's vernacular houses.

Somerset Vernacular Building Research Group

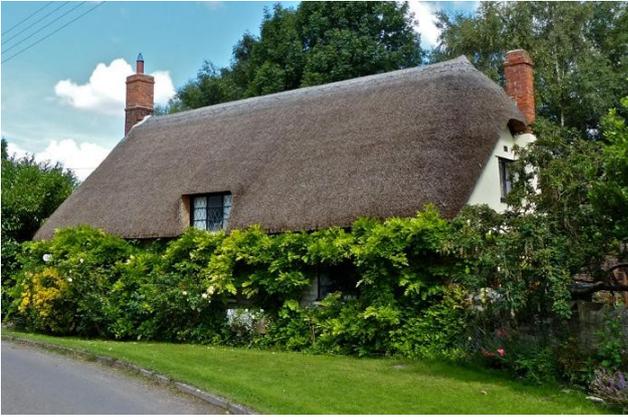
The Anchorage, Thorney.

This house was surveyed, by the Somerset Vernacular Building Research Group, in 2017. The survey just happened to be on my desk when the geometry was being considered. The roof pitch had been recorded at 51° so it was clearly a target for research. The house was originally of cob, this remains in the rear wall, and has a suggested C17 date.

The building section was extracted from the pdf survey report and imported into a cad program. A 3m line was drawn and the section was stretched until the scale bar was the length of the 3m line. All stretching operations maintain the proportions of the original. We are now able to work on the section at full scale.

The geometry was also imported and stretched to the internal building width.

We have to allow for the limitations of surveying, drawing and the age of the building, and later modifications. Bearing this in mind the geometry clearly suggests the ridge position.

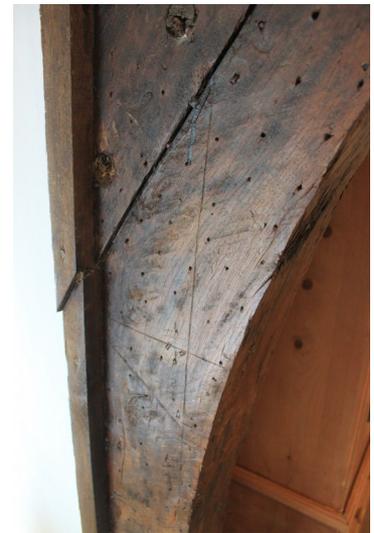
We know that jointed cruck buildings were referenced to the internal face of the posts as scratched layout marks have previously been recorded on other buildings.

Jointed Cruck scratched layout marks.

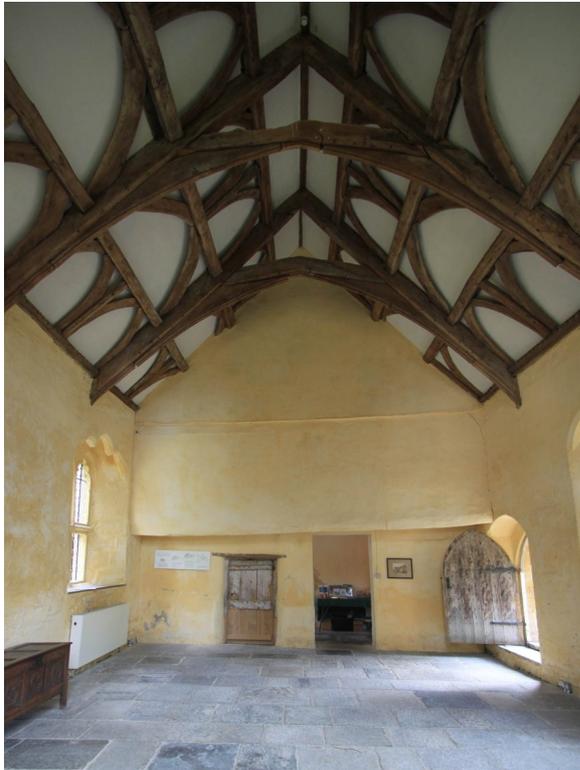
The Treasurer's House, Martock

A National trust property, open to the public. The building dates to 1293, with the hall roof being C15. The survey drawings are of small scale, so the main hall will be resurveyed at some point. It is included at this time as it fits the geometry with an outer wall alignment. We know the flagstone floor is not original, being replaced in recent memory, there may have been a level change at this time. The roof pitch was not recorded.

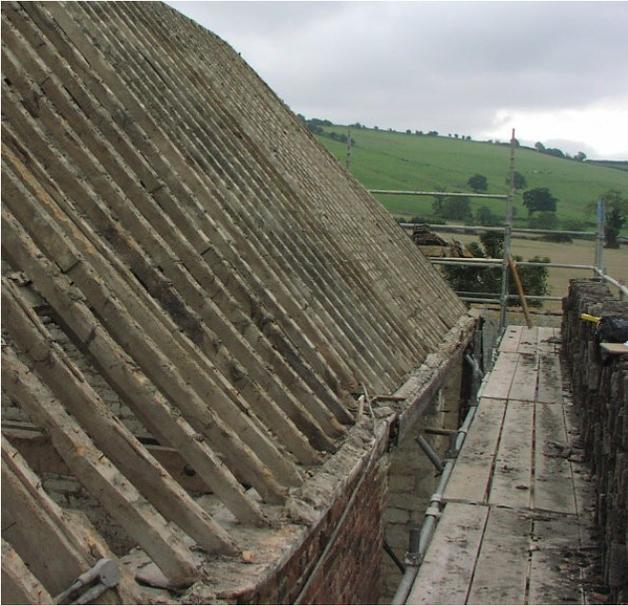
Dealing with different roof coverings initially caused some concern. The apex of the geometry aligns with the apex of the common rafters. The hypotenuse of the triangle is therefore on top of common rafter. Where this meets the outer walls we have a sharp corner, this is fine for a tiled roof but causes issues with a thatched roof.

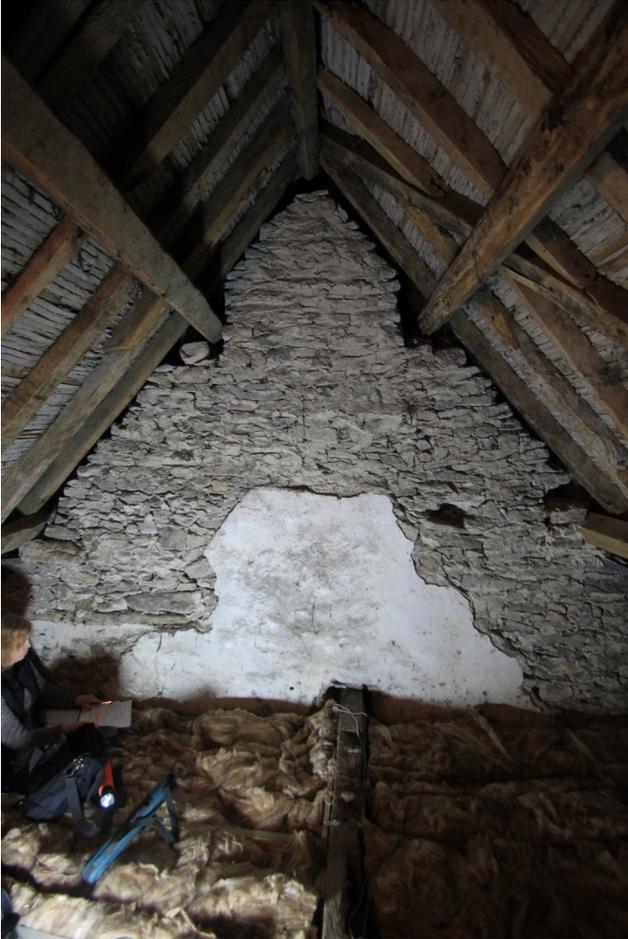
Surveyed by SVBRG in 2013, this house is given a suggested C17 date. The house is now two storey but a plaster “shadow line” of the original roof still exists in the loft so it is possible to interpret the original ridge height.

Woodlands, old roof line
