Report first published in SAHNS Autumn Quarterly Review 2006

SOMERSET VERNACULAR BUILDING RESEARCH GROUP

The following buildings have been recorded and copies of the full reports and survey drawings have been deposited in the Somerset County Record Office and the National Monuments Record at Swindon. The photographs below were taken by John Rickard.

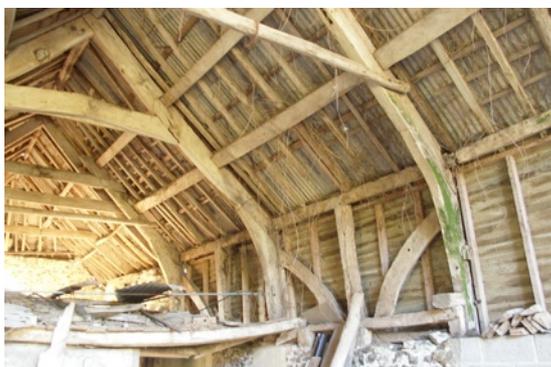
Fig. 1 Barn at Whitehall Farm, Combe St Nicholas

century farm buildings, only a barn (Fig. 1) and a waggon and implement shed survive.

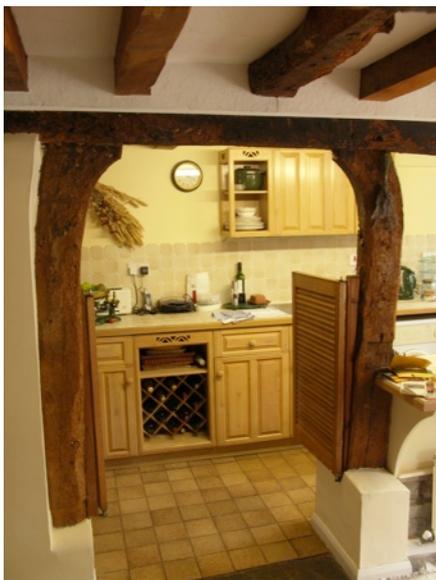
Fig. 2 Willow Cottage, Alhampton, 15th-century doorframe

house dates from the 15th century (based on tree-ring dating of similar features elsewhere in Somerset) (Figs 2 & 3) and the smoke-blackening shows that they formed part of two open-hall houses. With the limited evidence available, it is not possible to establish the plan form of these medieval houses. In the second half of the 16th century, upper floors were inserted in one of the houses (now divided between the two cottages) and the other was ceiled late in the 16th century. The 1888 OS map indicates that the properties were then divided into three and extended further to the north and east.

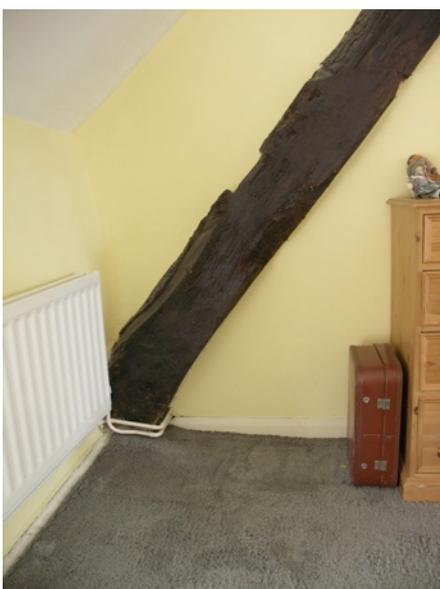
Fig. 3 Willow Cottage, Alhampton, principal rafter

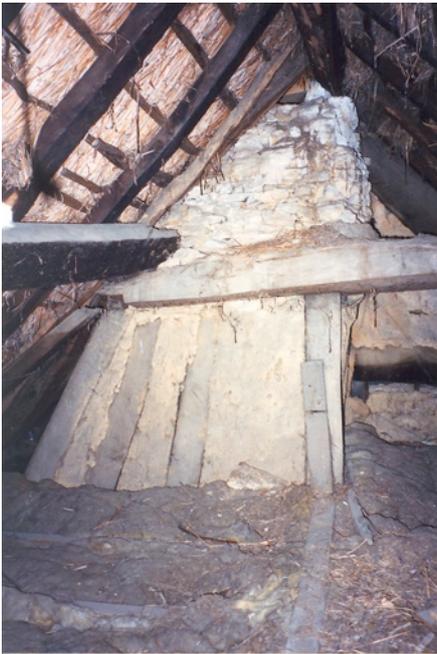
The house is currently divided into two at the cross-passage. The extent and degree of the smoke-blackening together with the details of the jointed-cruck roof indicate that the house probably dates from c. 1500. Originally built of cob, it comprised a service room, cross-passage, hall (all open) and an unheated inner room with a solar chamber over. The irregular alignment of the back wall cannot be explained, particularly as the roof structure is considered to be of one build. In the late 16th century, upper floors and a smoke-hood were inserted (Fig. 4). This appears to be the only surviving smoke-hood in the village. The kitchen fireplace and stack (and possi-

Fig. 4 Bramble Cottage, Haselbury
Plucknett, smoke-hood

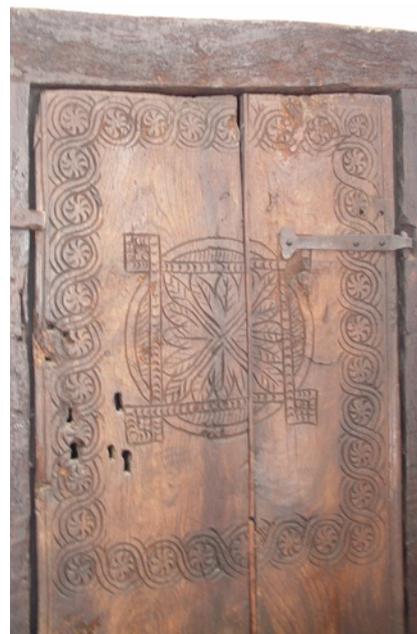
The absence of the original roof structure makes interpretation difficult, but the plan appears to be a farmhouse of three rooms in line, comprising kitchen, hall and central unheated service room. Adjacent to the kitchen fireplace was a curing chamber (now gone) and access to the room above is by an elaborately carved door on the first floor (Fig. 5). Details of the beams indicate

Fig. 5 Eastfield Farm, Lydford on Fosse, decorated door on first floor

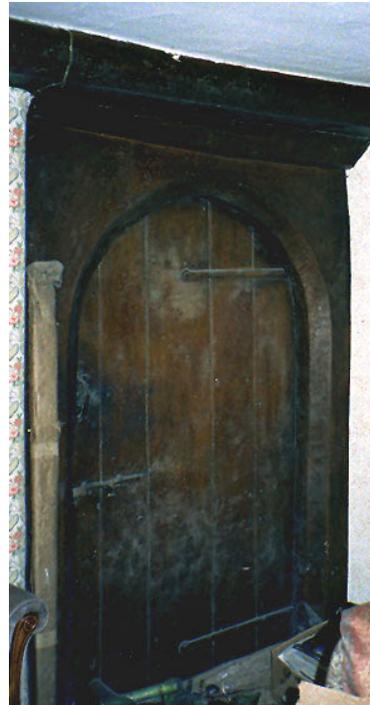
The house is comprised of two parallel ranges; the older being three units of one-and-a-half storey and the other being a double-fronted two-storey addition. The details of the earliest phase suggest a date in the 16th century (Fig 6), but the original layout remains uncertain. In the 17th century the house was remodelled and it appears that a cross-passage was created utilising part of a parlour and a new staircase was inserted. An addition, accessible from the house on the

Fig. 6 Coombe Grange, Nailsea, 16th-century doorframe

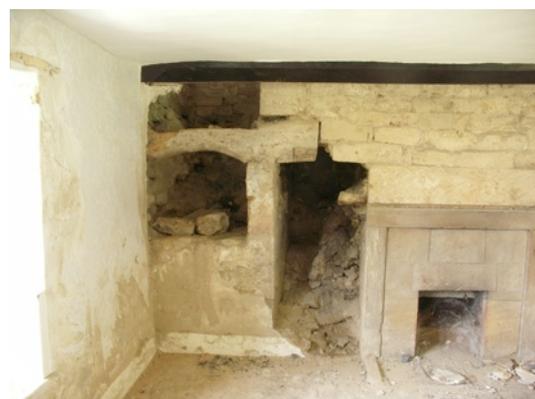
Fig. 7 Old Harp House, Over -Stratton, remains of bressumer and access to curing chamber

both with stair turrets, have been recorded at Brompton Ralph and North Petherton. In the early 17th century the house was re-fronted, when the inner room became a parlour with a new fireplace inserted and the curing chamber in the kitchen was replaced by an oven (Fig. 7). By the 18th century the kitchen had been upgraded to a living room.

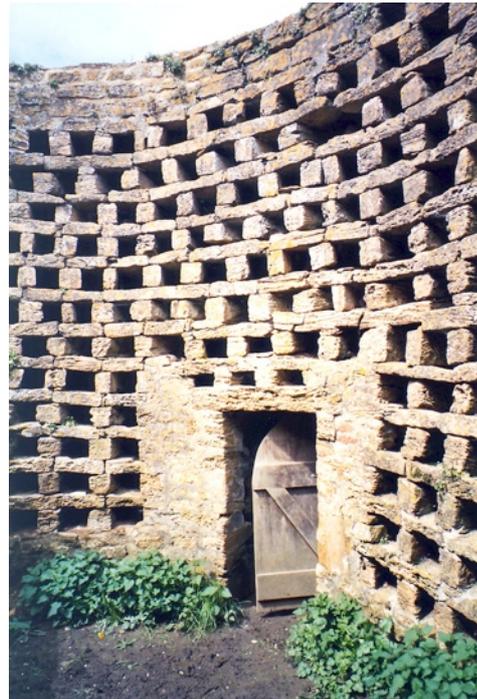
dieval barn, re-roofed and the porch rebuilt in the 18th century. A second barn, basically medieval but largely rebuilt in the 18th century. This was gutted by fire in 1969 and is now roofless. The stables were originally of two rooms with a hay loft over, but were rearranged internally in the 19th century. A cart-shed with granary over, formerly with a lean-to, is also now roofless. Lastly, the medieval dovecote (Fig. 8)

Fig. 8 Dovecote at Priory Farm, Stoke-sub-Hamdon

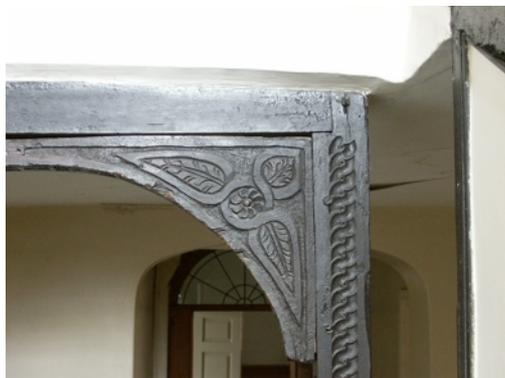
Fig. 9 Tintinhull House, spandrel at foot of back stair

changes it is difficult to determine the original plan-form of Tintinhull House. The inscription ‘1630 N’ on the gable of the cross-wing is likely to represent the date of the earliest phase of building and the conjecture is that it was two storeys and L-shaped (Figs 9-11) The house was enlarged to a rectangular plan with the addition of the two-and-half storey west front in classical style – described by the VCH as “an unusually perfect example of its period”. This work was probably undertaken for Andrew Napper, who acquired the property by 1722 (Fig. 12). Further

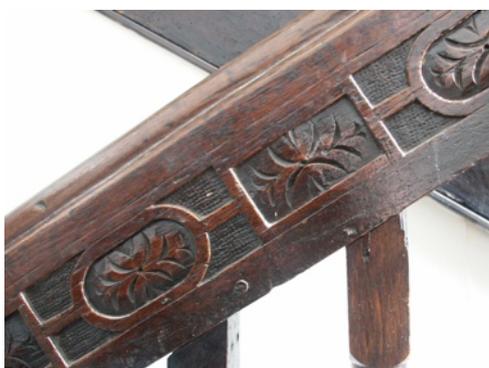
Figs 10 Tintinhull House, details of hand-rail to back stair

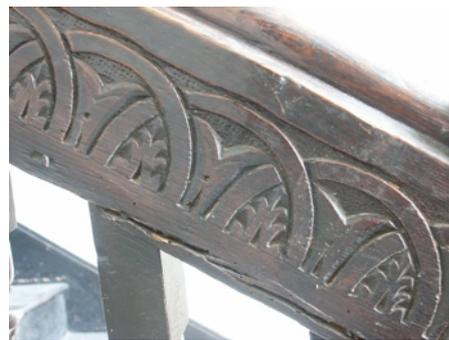
Figs 11 details of handrail to back stair

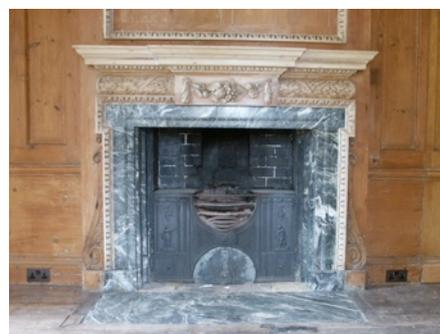
Fig. 12 Tintinhull House, 18th-century chimney-piece
